A STUDY OF HYDROGEN EMBRITTLEMENT IN AUTOMOTIVE FASTENER STEELS

B. Lonyuk^{1*}, R. Hop², D.N. Hanlon¹, S. van der Zwaag³, J. Zuidema³ and A. Bakker³

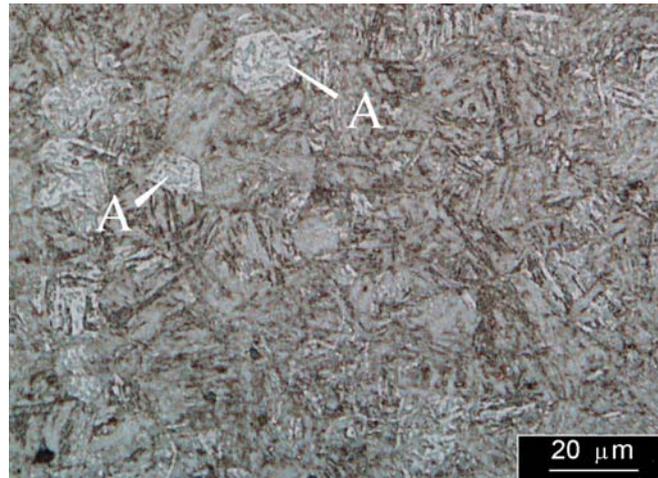
Figure 1: Photomicrograph of the tempered structure. The matrix composes mainly heavily tempered α' with some scattered polygonal ferrite *A*.
