FRACTURE BEHAVIOR OF A CORRODED ANNULAR PLATE UNDER A MULTI-AXIAL STRESS STATE

M.OHASHI

National Research Institute of Police Science 6-3-1, Kashiwanoha, Kashiwa, Chiba277-0882, Japan

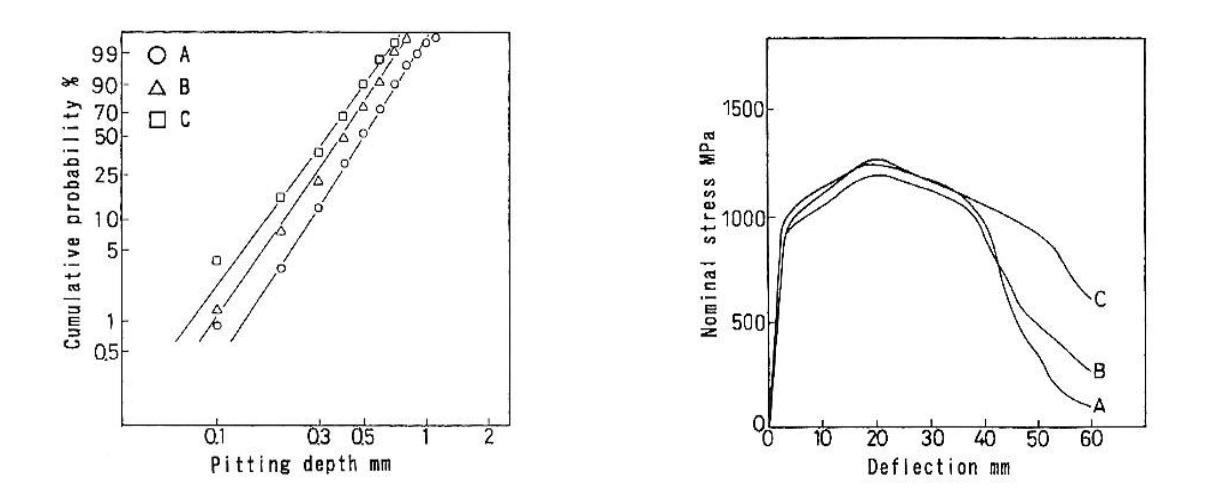
Fig.3. Weibull distributions of pitting depth Fig.4. Nominal stress versus deflection for specimen A, B and C. curves for specimen A, B and C.

The distribution of pitting depth can be approximately described as a Weibull distribution. Three specimens were found to be corroded to a greater depth in order of specimen A, B and C. While, the probability distributions of stress concentration factors are fitted to log-normal distribution. The median values for specimens A and C were 2.1 and 1.9, respectively.

Fig.4 shows the results of bend tests. The nominal stress σ_n is given by

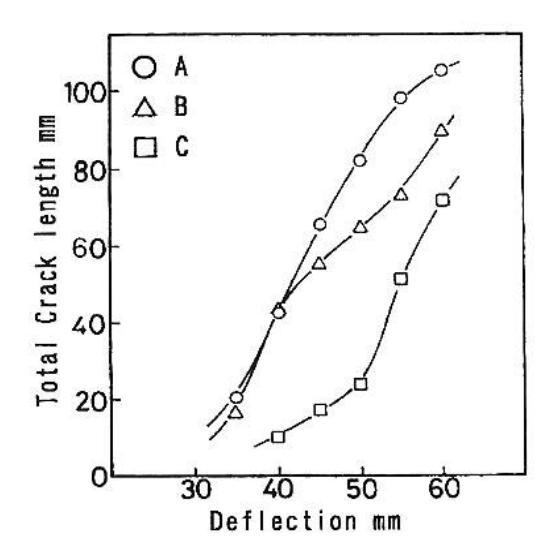
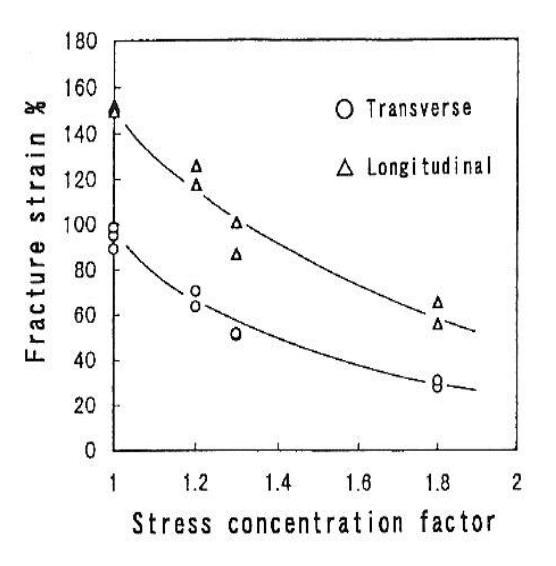
Poor ductility of the annular plate in the transverse direction was assumed to promote crack growth. Fig.10 shows the relationship between the fracture strains and stress concentration factors of tensile specimens[2] for both the transverse and longitudinal directions. The fracture strain in the transverse direction was about a half of that in the longitudinal

Fig.10. Relation between fracture strain and stress concentration factor.

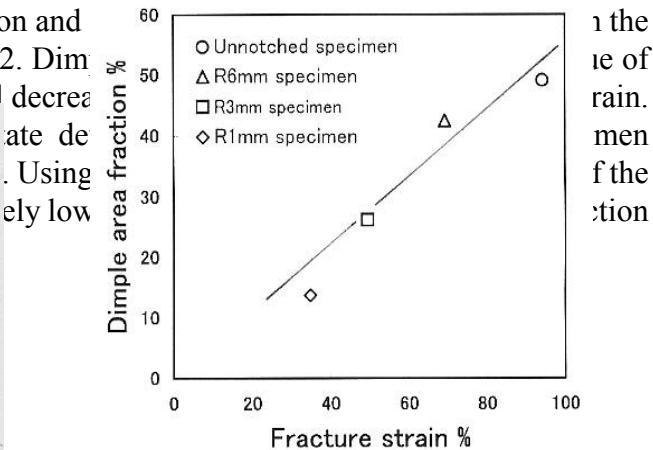
Also, poor ductility of the annular plate was well explained from a detailed fractographic examination. A typical fractograph of the annular plate is shown in Fig.11. The fracture surfaces are composed of equiaxed dimple area and featureless zone that is supposed to be caused by cracking and decohesion of non-metallic inclusion. The greater portion of the fracture surface is covered by featureless area. An average value of area fraction covered by dimple for 14 views was found to be a small value of 22% because of low ductility of the annular plate.

The relationship between dimple area fraction and transverse direction was developed in Fig.12. Dim \ge about 50% for the unnotched specimen and decree 5

Fig.11. SEM fractograph of the annular plate. Fig.12. Relation between dimple area fraction and fracture strain.
