Characterization of Explanted Bileaflet Mechanical Heart Valves and Correlation with Patients' Clinical Data

M.F. Brunella¹, G. Bruschi², S. Farè³

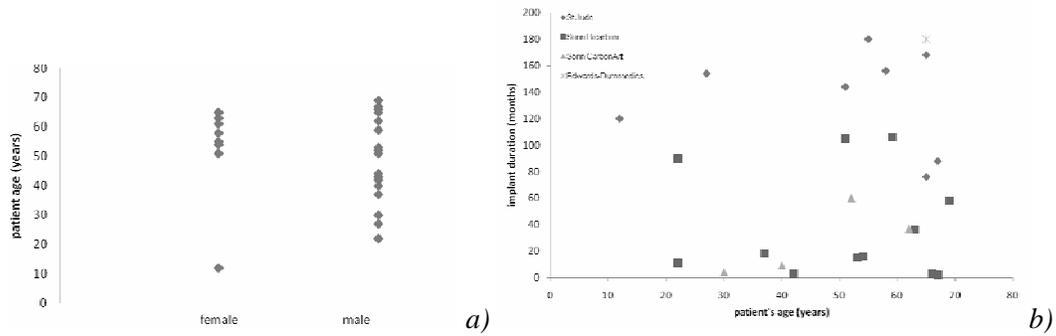
Among the considered MHVs, 9 valves were implanted in women, and 19 in men; 20 valves were implanted in aortic position and 8 valves in the mitral position (Table 1). The patients age at valve implant ranged from 12 years (#11) to 69 years (#46). As possible to observe in figures 3a and 3b, no correlation was identified among the age and the gender of the patients, nor the duration of implantation.

Figure 3 – a) Patient's gender vs patient's age; b) patient's age vs implant duration. No correlation can be evidenced.

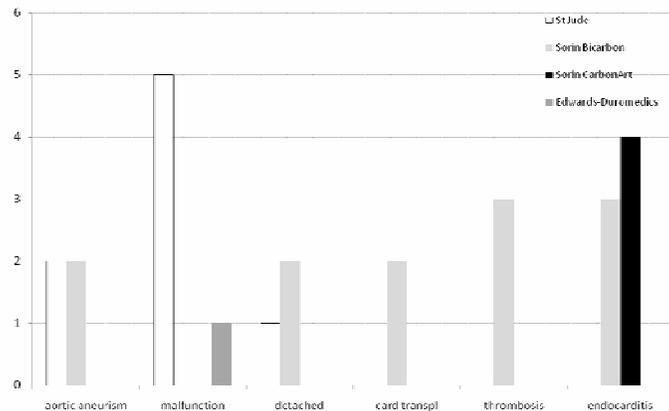
From clinical data, different reasons for explantation were evidenced (Figure 4); in particular, all the malfunctioning valves showed a high degree of stenosis, confirmed by the high values of the transvalvular gradients, as observed, for example, for valves #22, and #23. After explantation, for 11 valves the presence of pannus or thrombus formation was observed (Figure 5). Furthermore, for different prosthesis, the high values of the transvalvular gradients can be attributed to the difficult movement of the two leaflets. For valves #2 (size 21), #15 (size 21), and #25 (size 23), the values of pressure gradients are higher than those expected for the St Jude valve model (i.e. 14.4 ± 8.3 mmHg, 7.2 ± 2.2 mmHg, respectively for max and average gradient [8]). For two valves (valves #7 and #27) the malfunction was hidden by more severe pathology (i.e. aneurism of the ascendant aorta).

Figure 4 – Different reason for explantation for each model of investigated bileaflet valves
