Examination of Fatigue Crack Origins in Aircraft Turbine Blades Using Serial Sectioning Techniques

Sylvie Dionne¹, Tim Lang¹, Jian Li²

¹*Transportation Safety Board of Canada, Ottawa, Canada;* ²*CANMET-Materials Technology Laboratory, Ottawa, Canada*

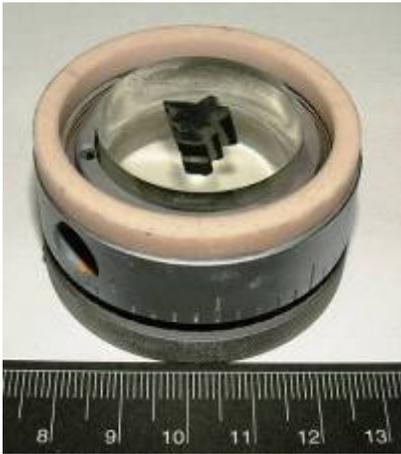
Conventional metallurgical sections were prepared from the subject blade to determine the size of the region affected by the seam defects. The blade was mounted in transparent cold setting epoxy and sectioned using a tool capable of controlled material removal in increments of 20 microns (Figure 9). Section polishing was accomplished using conventional metallographic preparation techniques. In total, twenty-five polishing steps were completed to document the microstructure in the trailing portion of the blade. The location of each plane of polish was determined using features on the fracture profile and the FIB sections as reference points. Figure 10 shows the position of the plane of polish after the 8th (line A, 400 μm from the blade trailing edge) and 23rd (line B, 910 μm from the blade trailing edge) polishing steps, respectively.

Figure 9: Controlled material removal tool employed for preparation of blade metallurgical sections.
