# Failure Investigations of Cracked Spherical Bearings in Aircraft

X.Wu, A.Bourgeois  
*Bombardier Inc., Montreal, Canada*

During aircraft overhaul, six spherical bearings were found cracked in bearing balls made of 440C stainless steel. The cracked bearings were used for different aircraft joints and came from different suppliers. Investigations revealed that all the cracks originated from the ball surface and extended in the axial direction of the bearing. Intergranular fracture was the common characteristic found in most of the cracked balls.

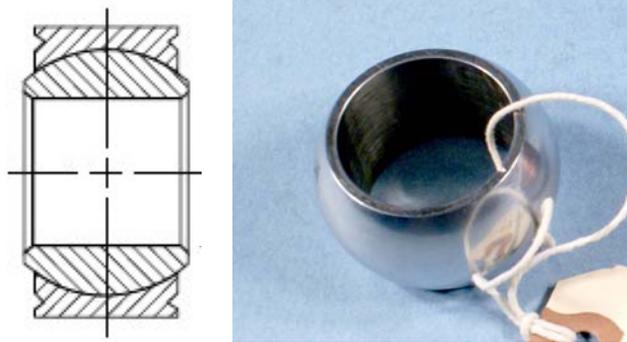
All the spherical bearings consisted of a truncated ball ring and a race swaged onto the ball (Fig. 1). The bearing ball was made of 440C stainless steel and was hardened to minimum 55 HRC. The race was made of a different stainless steel and was not as hard as the ball. Chromium plating was applied on four bearing balls to their spherical surfaces and flat side faces. The bearings were lubricated by different lubricants. Table 1 summarizes the cracking phenomena, surface finish and lubricant of each bearing. Since only the investigations of the bearing

Fig. 1. The bearing assembly and a released bearing ball
