## Hydrogen embrittlement of a torsion bar in a military aircraft

**ABSTRACT.** The torsion bar of the emergency braking system of a military aircraft, a forged block of a maraging low-carbon steel, was found fractured during an in-service inspection. Visual examination of the bar showed several defects associated to the missing and blistering of finishing on both external and internal walls. Further examinations using a Field Emission Scanning Electron Microscopy (FESEM) as well as the X-ray Energy Dispersive Spectroscopy (X-EDS) and metallographic microscope showed pits in the protective finish from which started inter-granular corrosion. FESEM observation also revealed grains disbonding, in according to a hydrogen embrittlement phenomenon. Finite Element Analysis (FEA) also performed to evaluate stress distribution pointed out the orthogonality between the main stresses direction and the helical fracture.

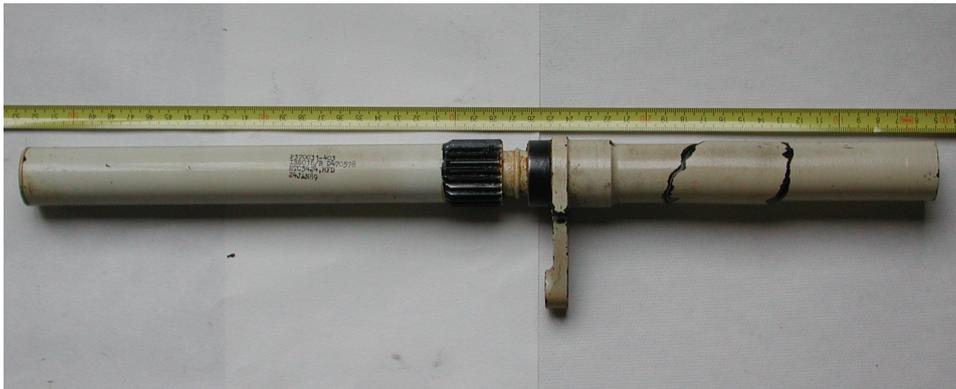
Figure 2: Torsion bar.

**T**orsion bar consists of two concentric tubes connected at the extremities by two annuluses (see Fig. 2). In particular, the external one is partitioned in two pieces: the first one is 27 cm long and ends with a locknut at its free extremity, the second one, 20 cm long, ends with a lug bolt at which is connected the compound lever.

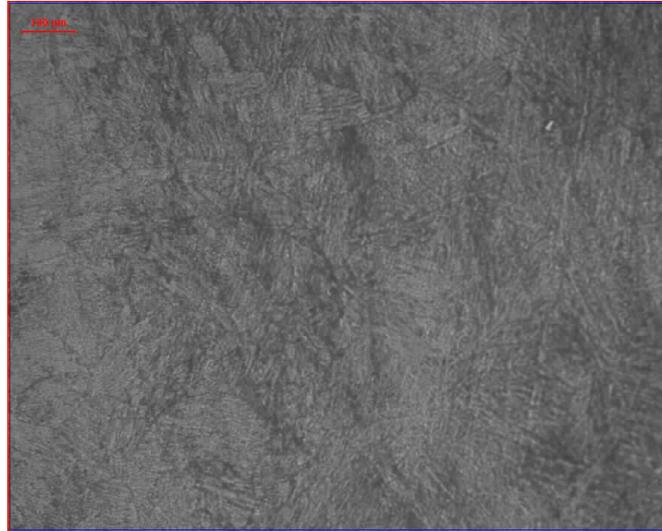
Figure 11: Core microstructure.

The core shows a typical low carbon maraging steel microstructure (see Fig. 11). A 75  $\mu\text{m}$  finishing, which consists of three different layers, is applied on a 30  $\mu\text{m}$  phosphate coating (see Fig. 12). Both, phosphate coating and finishing, are defective or absent in several spots.

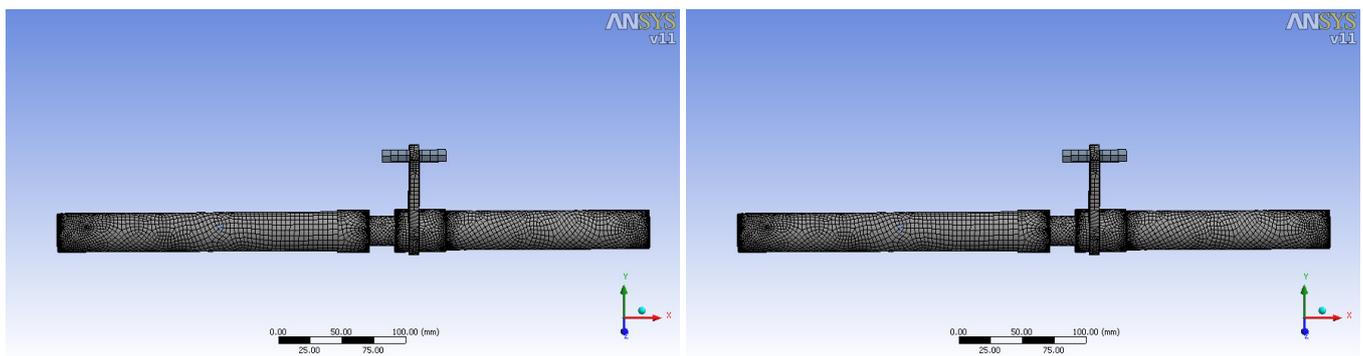
Figure 14: Mesh.

To identify the stress distribution on the torsion bar related with in-service condition of full up hook, a FEA was performed (Fig. 14) using a linear formulation.

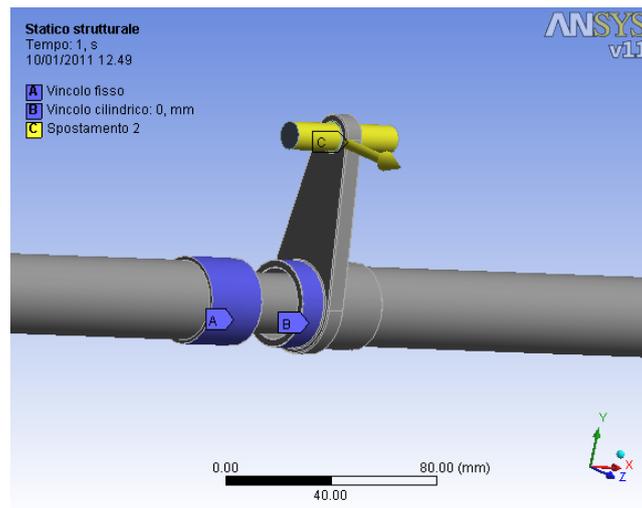
Figure 15: Constraints and displacements.

It was assumed the locknut as a fixed end (Fig. 15 - A) and only rotation around the main axis was allowed to the lug bolt end (Fig. 15 - B). To the lever connected to the lug bolt was assigned a displacement of 1 mm (Fig. 15 - C), a value probably quite lower than the real one generated during pre-charging operation.
