Fatigue Behaviour of DLC Coated Magnesium Alloy in Laboratory Air and Demineralized Water

Abstract. Rotary bending fatigue tests were performed in laboratory air and demineralized water using DLC-coated wrought magnesium (Mg) alloy, AZ80. Two film thicknesses, 3.5 μ m and 25 μ m, were evaluated in order to investigate the effect of DLC coating on fatigue and corrosion fatigue behaviour. In laboratory air, the fatigue strengths of the DLC-coated specimens were higher than those of the bare ones and increased with increasing film thickness. This was because hard DLC film with high coating adhesion suppressed slip deformation on the specimen surface. In demineralized water, fatigue strengths were considerably decreased due to the formation of corrosion pits in the bare specimens. Thin DLC film could not improve corrosion fatigue strength due to the penetration of the solution through the pre-existed hole defects in the film, while thick DLC film could improve corrosion fatigue strength because penetrating paths were eliminated during long and two-step DLC deposition process of 26 hours.

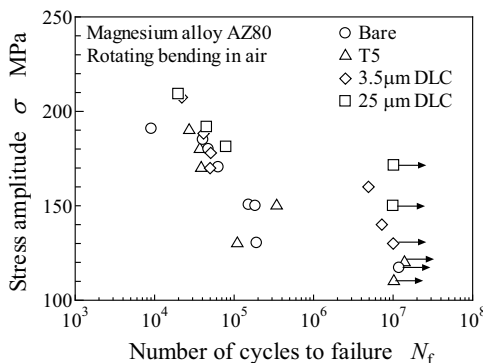
Fig. 6 *S-N* diagram in laboratory air.

Fatigue Strength. Figure 6 represents the *S-N* diagram for the bare, T5-treated, 3.5 μ m and 25 μ m DLC-coated specimens in laboratory air. The fatigue strength of the bare specimens is similar to that of the T5-treated ones, which have the same thermal history with the 25 μ m DLC deposition process. This indicates that the effect of the thermal history during DLC deposition on fatigue strength could be neglected. The DLC-coated specimens exhibit higher fatigue strength than the bare ones, and the fatigue strength is dependent on film thickness. The fatigue strengths at $N=10^7$ cycles are 120MPa, 130MPa and 170MPa for the bare, 3.5 μ m and 25 μ m DLC-coated specimens, respectively, indicating that the thicker film could achieve higher fatigue strength.

Fatigue Behaviour in Laboratory Air. As shown in Fig.6, the fatigue strengths of the DLC-coated specimens were higher than that of the bare one, and thicker film resulted in higher fatigue strength. Figure 13 shows the appearance of 25µm DLC film observed on the fatigue crack growth path ($\sigma=240\text{MPa}$). It is evident that fatigue crack grew stably through the film leaving a striation like pattern. Delamination of the film occurred neither at crack initiation site nor through crack growth path. This indicates high coating adhesion regardless of film thickness. In addition, the Vickers hardness of DLC film deposited by PECVD is estimated about 2200 [9]. Consequently, high hardness and adhesion of DLC film suppressed slip deformation on the specimen surface and led to the higher fatigue strength than the bare specimen. It is believed that the thicker film could suppress slip deformation more effectively. It should be noted that in Fig.13 (b), a clear line indicated by arrows is recognized at the mid thickness of the film due to the two-step deposition process.

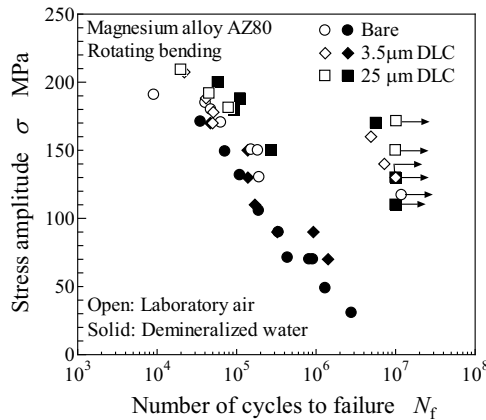
Fig. 9 $S-N$ diagram in demineralized water.

Fatigue Strength. Figure 9 represents the *S-N* diagram for the bare, 3.5 μ m and 25 μ m DLC-coated specimens in demineralized water. The test results in laboratory air and demineralized water are shown by open and solid symbols, respectively. The effect of T5-treatment on fatigue strength was not seen in laboratory air. Hence, fatigue tests using the T5-treated specimen were not conducted in

demineralized water. The fatigue strengths at high stress levels in demineralized water are similar to those in laboratory air in all specimens. In the bare and $3.5\mu\text{m}$ DLC-coated specimens, however, fatigue fracture occurs at stress levels much lower than the fatigue limit in laboratory air, and the fatigue limit is not seen in demineralized water. Furthermore, the $3.5\mu\text{m}$ DLC-coated specimen that had higher fatigue strength than the bare specimen in laboratory air exhibits nearly the same fatigue strength as the bare specimen in demineralized water. This indicates that thin DLC film could not improve corrosion fatigue strength. On the contrary, the fatigue strength of the $25\mu\text{m}$ DLC-coated specimen in demineralized water is much higher than those of the bare and $3.5\mu\text{m}$ DLC-coated specimens. The $25\mu\text{m}$ DLC-coated specimen shows clear fatigue limit, and the fatigue strength at $N=10^7$ cycles is 130MPa , which is lower than that in laboratory air, but higher than that of the bare specimen, indicating that the corrosion fatigue resistance was greatly improved by thick DLC film.
