# CHARACTERIZATION OF FATIGUE CRACK FORMATION IN MECHANICALLY SURFACE TREATED AUSTENITIC STAINLESS STEEL

I. Altenberger <sup>1</sup>, B. Scholtes <sup>2</sup>, U. Noster <sup>2</sup>, R. O. Ritchie <sup>1</sup>

<sup>1</sup> Lawrence Berkeley National Laboratory, University of California, Berkeley, USA

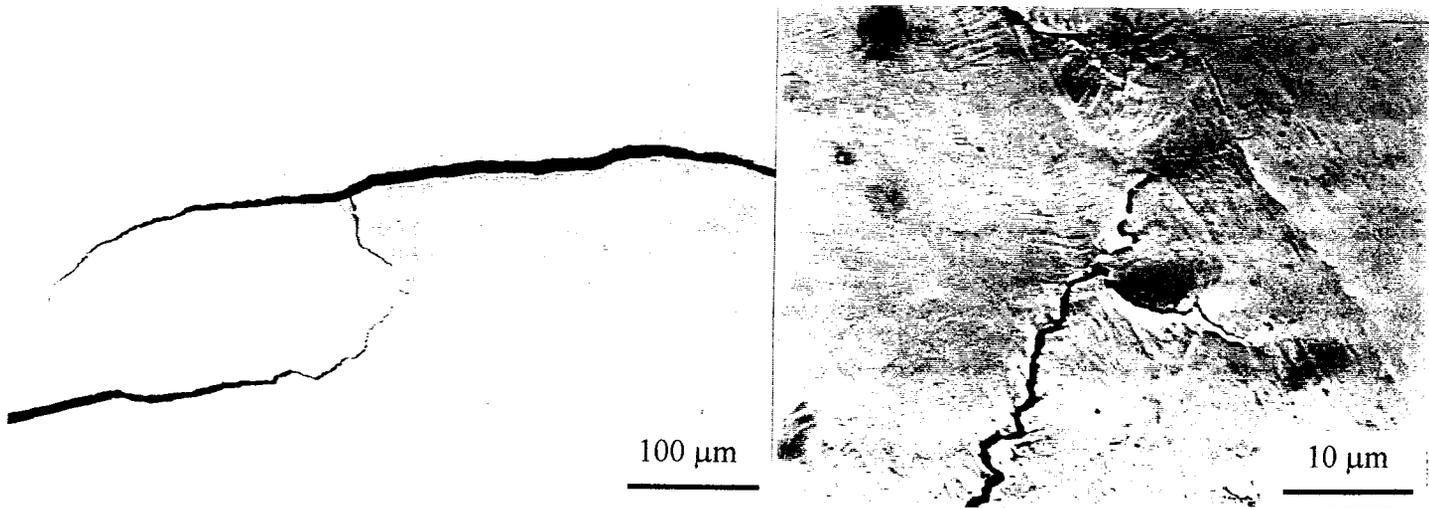
**Fig. 3:** Typical fatigue cracks in non-polished deep rolled AISI 304 ( $\sigma_a = 365$  MPa,  $N = 68000$  cycles)

In mechanically surface treated (e.g. deep rolled or shot peened) AISI 304 the surface fatigue damage mechanism is quite different (Fig. 3). Here, only an extremely low amount of surface plasticity (increase of surface roughness) around crack flanks and crack tips was detected. This lack of plasticity can be attributed to the surface treatment-induced nanocrystalline layer which effectively impedes dislocation movement and hence slip line formation. According to [11], dislocation pile-ups in nanocrystallites with a grain size of 20 nm or smaller are not effective enough to promote dislocation movement or Frank-Read-sources in neighbouring grains, thus only allowing the formation of brittle cleavage cracks [12] to relieve stress concentrations. Other characteristic features of fatigue damage in mechanically surface treated
