FATIGUE DAMAGE IN ADVANCED POLYMER MATRIX COMPOSITES

ABSTRACT

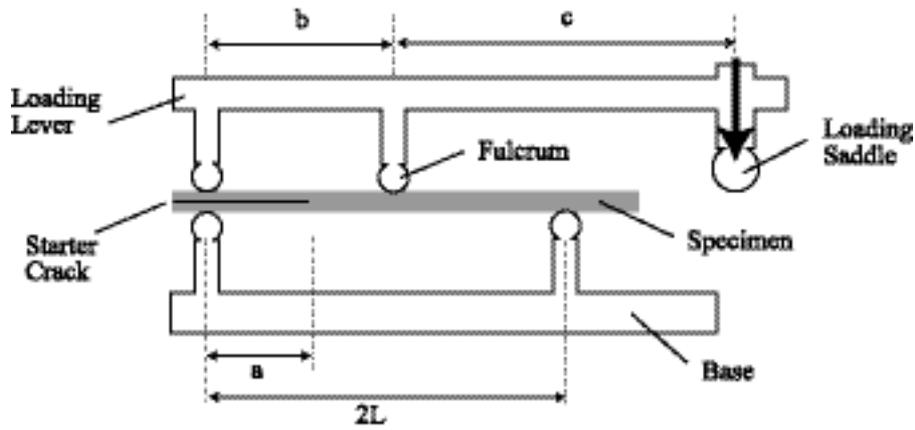
Figure 1. A Schematic of the Modified Mixed-Mode Bend Test Apparatus.

To investigate delaminations in more detail mixed-mode bend tests have been carried out using the modified MMB rig designed by Crews *et al*(2). A schematic diagram is shown in figure 1. Currently only static results are available.

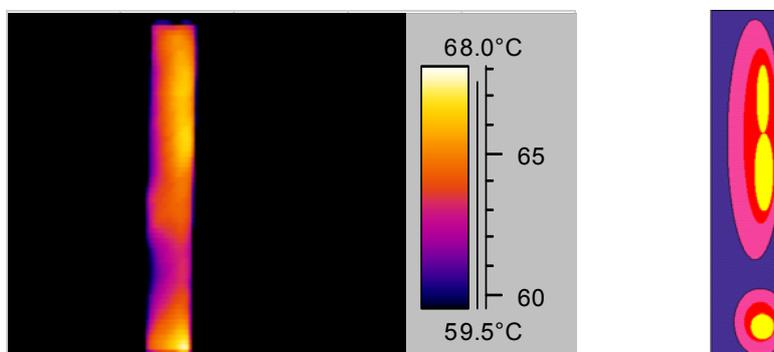
Figure 2. A Typical Thermographic Image Taken During a Fatigue Test and a Schematic of the Composite "Hot Spots" During Testing.

Alongside recording the cycles to failure for each specimen tested, a series of thermographic images were also taken. The change in temperature picked up by the camera has two causes 1) hysteresis heating and 2) local heating caused by friction induced by damage in the laminate such as crack faces shearing over each other. Figure 2 shows a typical thermographic image taken during a test and a schematic of the specimens "hot spots", where there is assumed to be the highest occurrence of damage.

All of the laminates in this series of tests showed varying degrees of delamination. These delaminations were visible with the naked eye at the outer 0/90° interface and were present from a very early stage of the laminates life. The images showed the progressive initiation and propagation of delaminations. However, the outer 0/90° interface had completely delaminated along the length and breadth of the specimen by approximately 50% of laminate life in all cases. The image in figure 2 is taken after the outer layer has fully delaminated and formed a sub-laminate. However, hot spots are still visible. This suggests that as there is a continued increase in temperature in the hot spot regions and that the early initiation of delamination in the outer 0/90° interface has induced some further damage mechanisms in this area such as delamination of the inner 0/90° interface or fibre fracture. This must be the case, as the laminates failed through the area of the hottest point in all cases and the delaminations alone were not enough to cause final failure or it would have occurred when complete delamination occurred. It is important to note here that all of the tests in the two series of experiments were conducted at an R ratio of +0.1, i.e. tensile-tensile fatigue. In this case the delaminations will not cause the final failure of the laminate. However, once fatigue moves into the compressive regime, the delaminations buckle and this may cause final failure of the laminate.

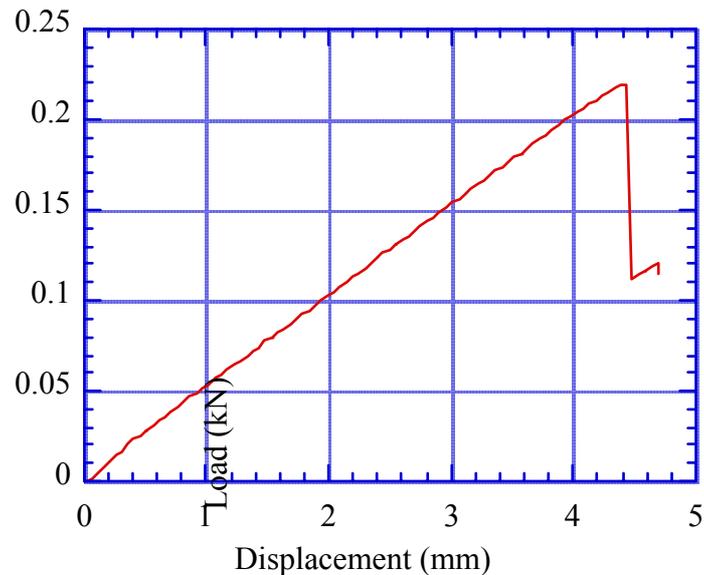
Figure 3. Graph of Displacement Against Load for Static MMB Test at 50% Mode I.

To investigate the different delamination interfaces being highlighted in the fatigue tests a series of work has begun to investigate delamination growth rates using MMB tests. This work is at a very early stage. Initial tests have begun to investigate the 0/+45° interface at a mixed-mode ratio of 50% M_I and 50% M_{II}. A typical graph is shown in figure 3. This graph shows the load–displacement response to be almost linear up to a maximum load where it is assumed that the delamination begins to grow. In this case the fracture was sudden and grew quickly. This is a typical response where mode II is dominant(2). The average maximum load was 0.254 kN. The overall strain energy release rate, G_t, for this test is 408.2 J m⁻². This was calculated using Eqns. 1 and 2(4), where the total G is the sum of the strain energy release rate due to mode I and mode II loading.
