DELAMINATION DETECTION OF BONDED COMPOSITE PATCHES FOR REPAIRING DAMAGED AIRCRAFT COMPONENTS BY BRAGG GRATING SENSORS

Z. Marioli-Riga¹ and E.E. Gdoutos²

ABSTRACT

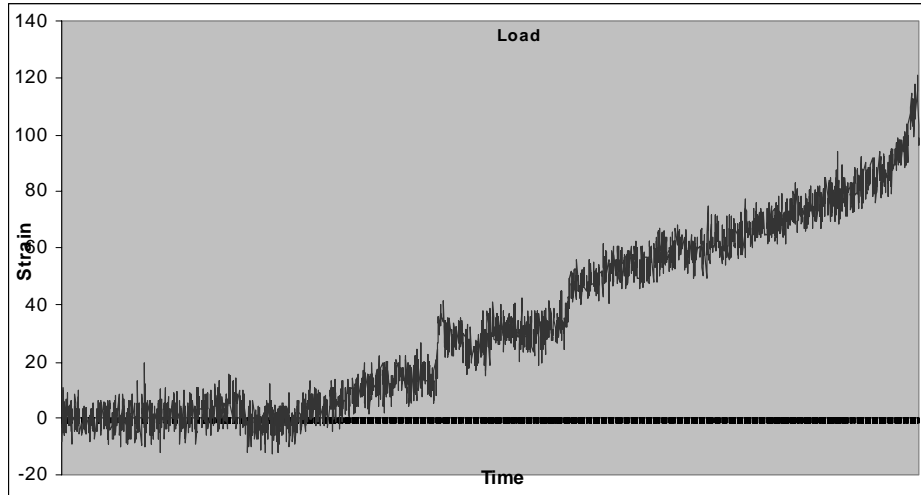
Figure 4: Strain versus time curve obtained by the Bragg optical fiber measurements

fiber Bragg interrogating system was connected to the embedded optical fiber. The specimen was sequentially loaded and unloaded to 1, 3, 5, 7, 10 kN and strain measurements were recorded. The test was performed under displacement control.

Figure 4 shows the strain measured by the fiber Bragg grating as a function of time, while Figure 5 shows the applied load as a function of grip displacement (time). Finally, Figure 6 shows the corresponding strain versus load curves.

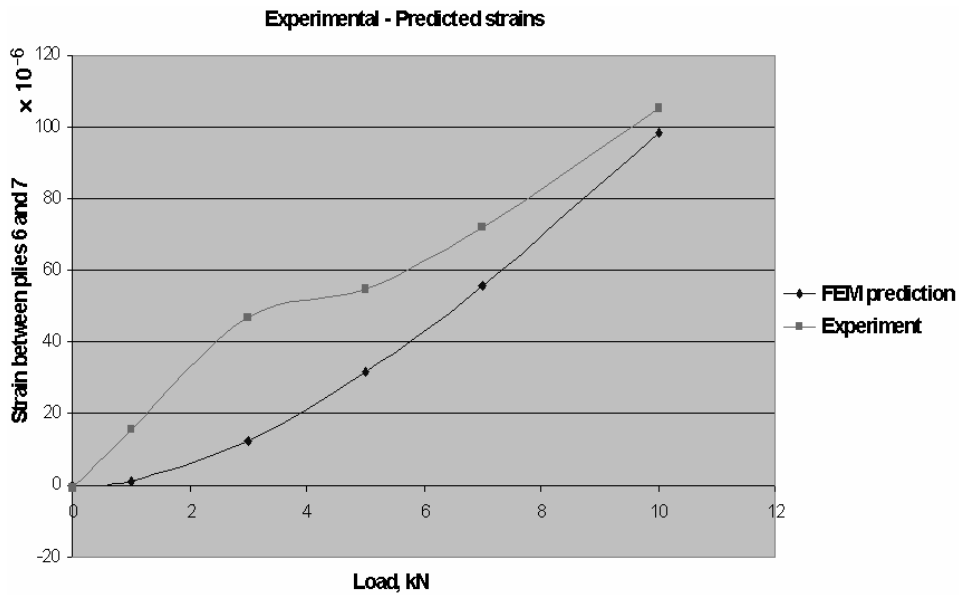
Figure 5: Experimental and finite element curves of strain versus load. Strains are measured in the composite patch between plies 6 and 7.
