# Surface Crack Initiation Phenomenon in Very High Cycle Fatigue

**Abstract** Very High Cycle Fatigue behavior of Stainless Steel AISI 310 has been investigated through ultrasonic fatigue testing. In fatigue cycles, a horizontal asymptote of S-N curve was found without any step at  $10^6$  cycles. Surface crack initiation was found irrespective of the stress level. However, the fracture surfaces of the material showed different behavior of crack propagation for different stages of fatigue cycles. It was found that up to  $10^6$  cycles, cracks initiated from surface defects and carbide precipitates present on the grain boundaries. The mechanism of crack initiation changed at low stress levels and slip bands and deformation twins were found at the surface of the specimen which acted as fatigue crack initiation sites. At lower stress levels, at or below fatigue limit, PSBs were developed but the cracks were not initiated. The lower slope in S-N curve was attributed to the development of PSBs all over the surface of the specimen before crack initiation.

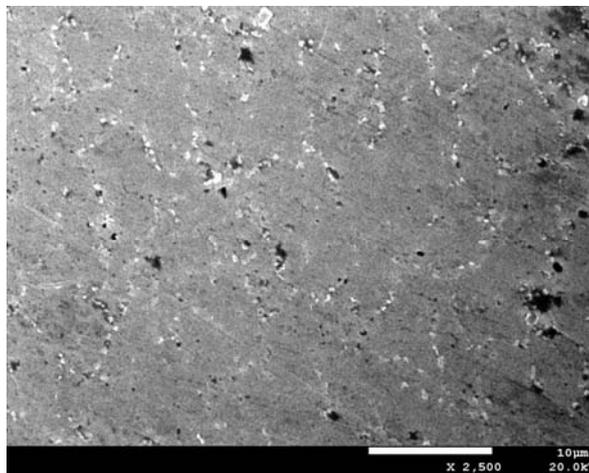
Figure 1. SEM Micrograph of the material. Carbide precipitates are prominent on the grain boundaries

Metallographic sample were prepared up to 0.05 micron finish and etched with Aqua Regia Reagent (15 mL HCL + 5 mL HNO<sub>3</sub> + 100 mL H<sub>2</sub>O) for 120 sec. The grain size of the material was determined by quantitative metallography and was found to be ~10 um as shown in Fig. 1. The grains were equiaxed and showed a random orientation. Carbide particles were obtained on the grain boundaries of the material. Elastic–plastic properties of the material were obtained by tensile testing according to ASTM standard E8 and are given in Table 1. Vickers microhardness tester was used at 200g load. The average Vickers hardness of the material was found as 370HV.

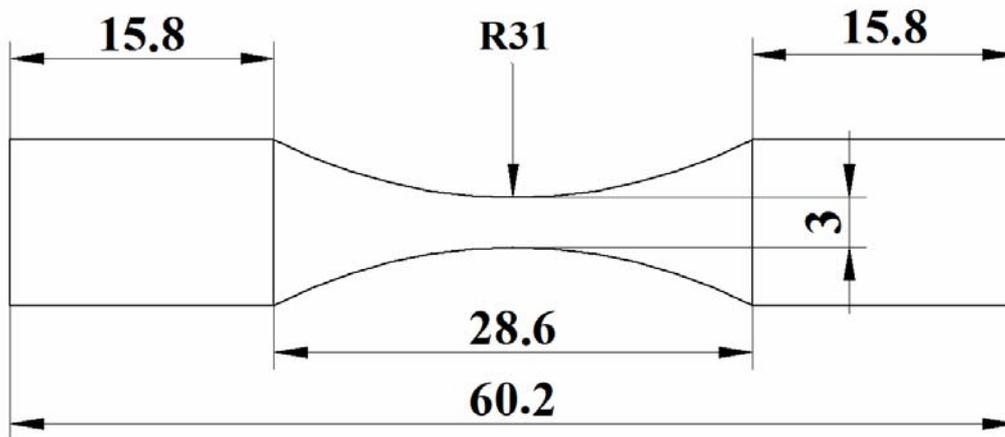
Figure 2. Schematic representation of fatigue specimen

The VHCF testing samples were designed to resonate longitudinally at 20kHz with the ultrasonic fatigue testing system. The detailed geometrical size of the specimens is shown in Fig. 2. The surface of the specimens was polished to surface roughness 0.2  $\mu\text{m}$ . Surface roughness of the material was determined with Atomic force microscope (AFM). Surface roughness  $R_a$  for different regions were measured and found up to 80nm.

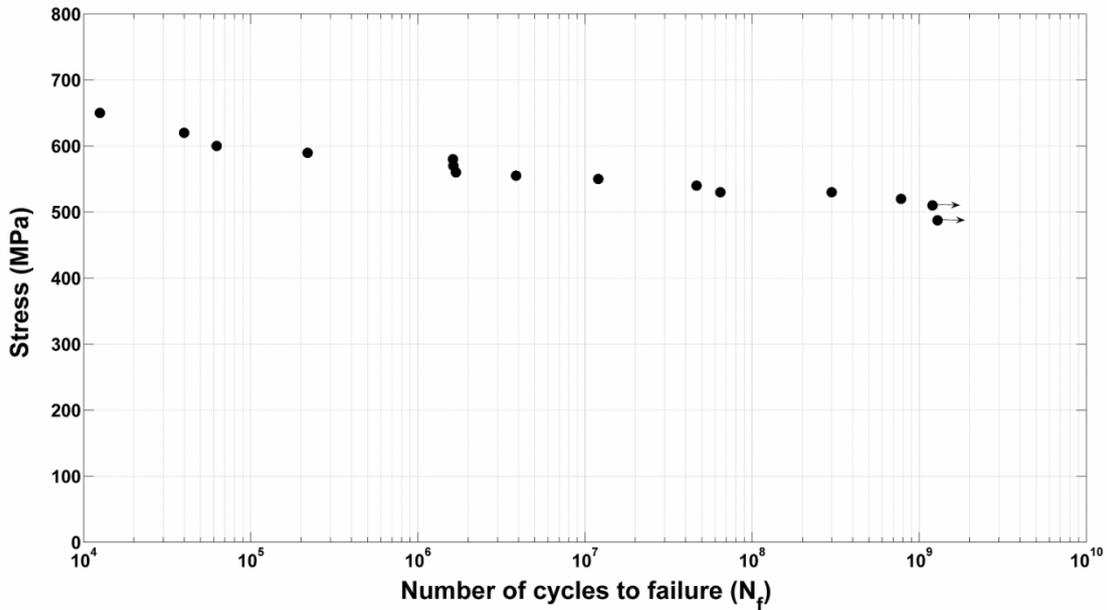
Figure 3. S-N curve for the material

Fig. 3 shows the S-N curve for the material. The curve showed a higher decreasing slope at higher stress levels up to  $10^6$  cycles. This showed that at higher stress levels, the fatigue life was continuously decreasing. A semi-asymptote type curve was obtained and the curve became almost horizontal after  $10^6$  cycles. This was in agreement with earlier studies where a horizontal curve was reported for stainless steels [3, 10]. The material showed fatigue limit at around 500MPa and exhibited run out samples. It was found that the fatigue fracture for this material can occur beyond  $10^7$  cycles up to  $10^9$  cycles, though the difference in the fatigue strength was only around 50MPa.

The little difference in fatigue strength between  $10^6$  to  $10^9$  cycles and lower slope of S-N curve may be attributed to the relatively lower UTS of the material [3]. It was found that owing to the lower slope, little difference in stress levels changed the failure cycles significantly. This showed that fatigue crack initiation and propagation at relatively lower stress levels required considerable increase in the fatigue cycles to yield a failure. On the other hand, this showed that for a very small increase in stress level, the fatigue cycles would reduce significantly. The difference in stress levels for fatigue life between  $10^6$  to  $10^8$  cycles was almost 30MPa. For engineering applications, where materials are designed to serve  $10^7$  to  $10^8$  fatigue cycles, only increase in 30MPa may reduce the fatigue life from  $10^6$  to  $10^8$  cycles, which is significant.

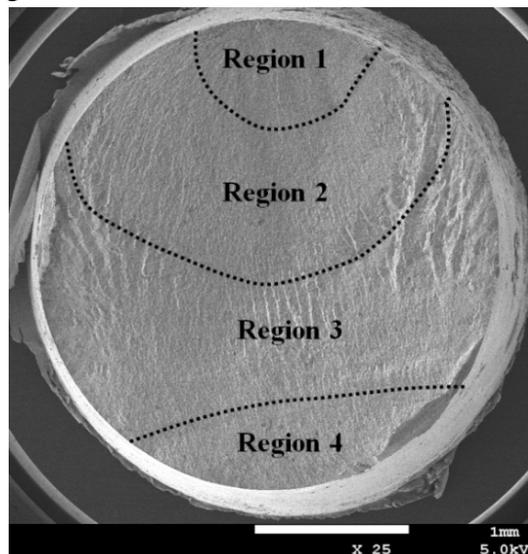
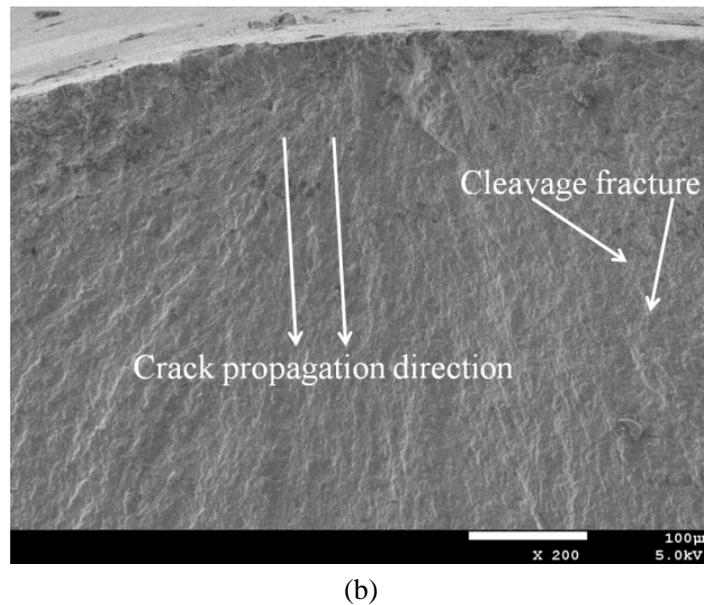
Figure 4. Fracture surface (a) sample failed at  $7.78 \times 10^8$  cycles (b) Crack initiation from the surface

Fig. 4 (a) shows the cross-section of the fracture surface of the specimen failed at  $7.78 \times 10^8$  cycles when loaded at 520MPa. It can be seen that the appearance of fracture was different at different locations and based on the appearance, four different regions were visible. Radial patterns of striations were observed having 110 to 130 $\mu$ m spacing between each other. The initiation site was a localized region on the surface of the specimen. Fig. 4 (b) shows the crack initiation region and crack propagation direction from the surface of specimen. The striations started from the crack initiation site and extended to more than three-quarter of the surface of specimens. The details about the regions are discussed elsewhere [18]. Cleavage fracture was observed with many secondary cracks and higher surface roughness.

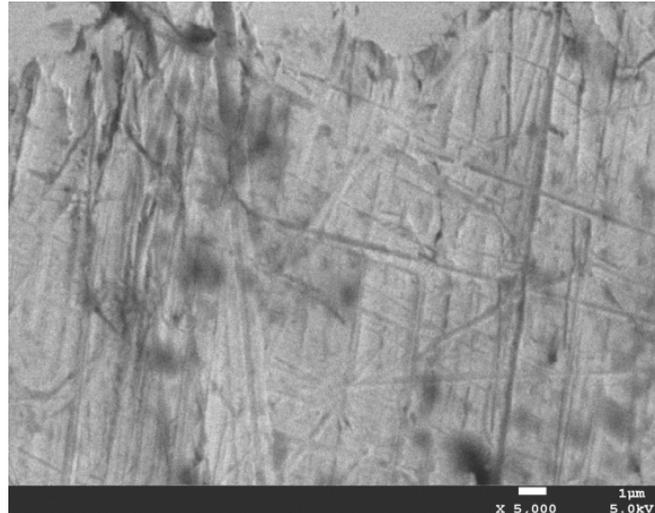
Figure 5. PSBs and dislocations on the surface of specimen failed at  $3 \times 10^8$  cycles (520MPa)

However, the specimens failed beyond  $10^6$  cycles showed high density PSBs and deformations on the surface. Fig. 5 shows SEM image of the surface of specimen failed at  $3 \times 10^8$  cycles. It can be seen that high density slip bands were all over the periphery of the specimen. The near fracture surface showed more number of PSBs. The majority of the dislocations were parallel to the loading directions which were wider and broader as compared to the others. However, some dislocations were observed transverse to the loading directions as well.

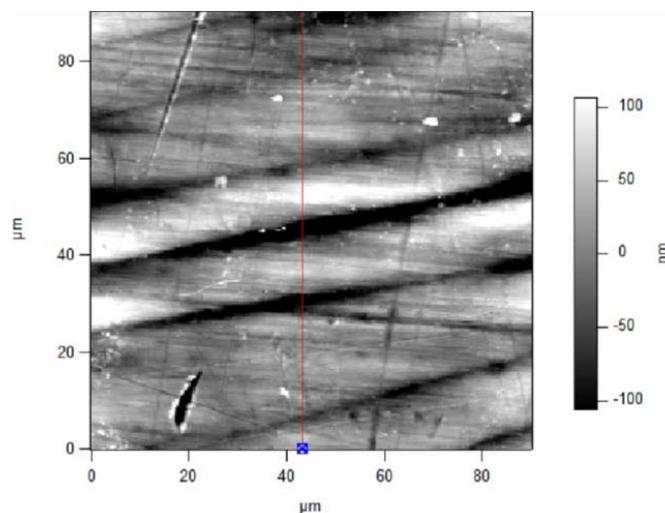
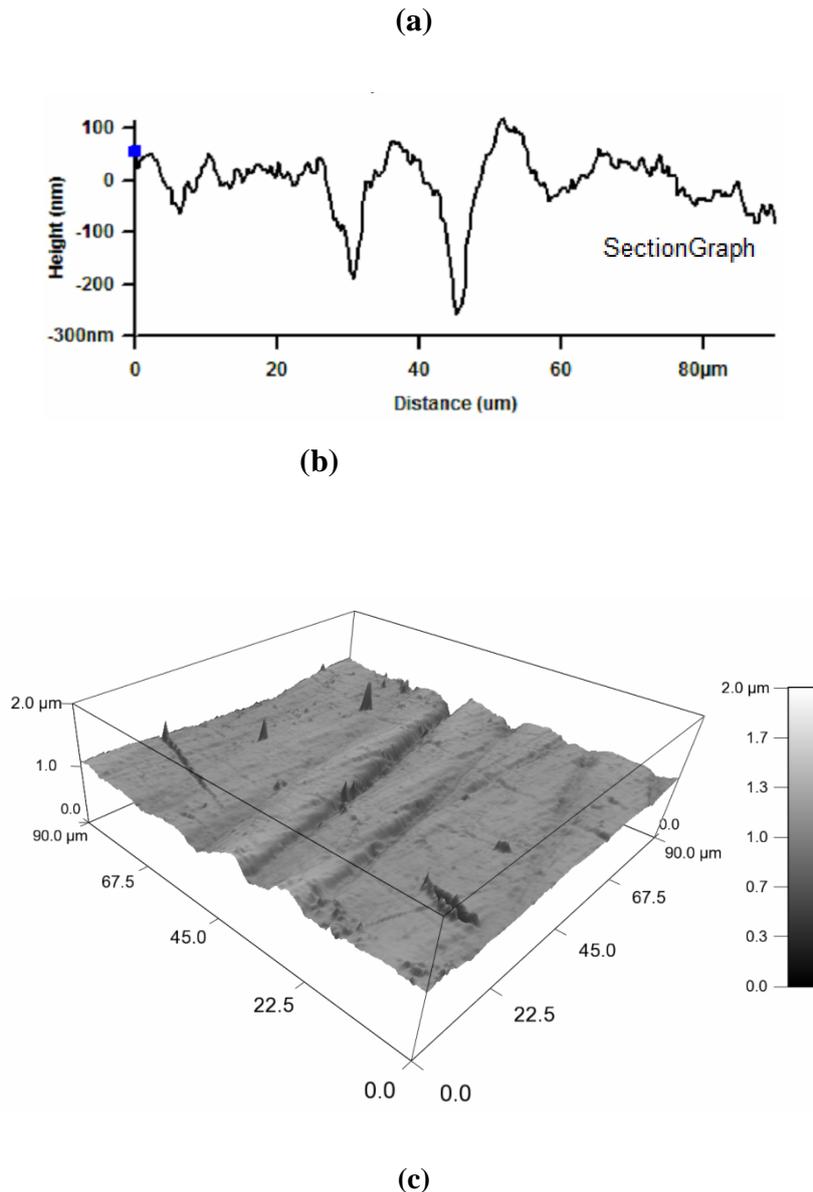
Figure 6 (a) AFM scanned image of an area near to crack initiation for the specimen failed at  $3 \times 10^8$  cycles (b) height profile through the area (from one corner to the other corner) showing significant PSBs and dislocations (c) 3D surface topography of the region

The topography of PSBs was investigated in detail through AFM. PSBs were present in the form of shallow intrusions and extrusions. Fig. 6 (a) shows 90um x 90um size AFM scanned image of a near fracture region in specimen failed at  $3 \times 10^8$  cycles. Fig. 6 (b) shows the 3D image of the area. The topography of intrusions and extrusions was like shallow scratches and waves, respectively [15-17]. Fig. 6 (c) shows the height profile data from the top corner of the area through the slip bands to the other corner of the area (shown by the red line in Fig. 6 (a)) showed many different crust and troughs. Several combinations of intrusions and extrusion, parallel to each other, were observed [16-17]. The distance between intrusions and extrusions was very small and maximum depth of the slip bands reached to around 250nm in some regions.
