Crack Propagation Behavior of SCM440H Low Alloy Steel Enhanced by Hydrogen under Long-term Varying Load and Static Load

Yoshiyuki KONDO, Masanobu KUBOTA and Katsuya SHIMADA

Kyushu University, Department of Mechanical Engineering,
744 Moto-oka, Nishi-ku, Fukuoka-shi, Fukuoka, 819-0395 Japan

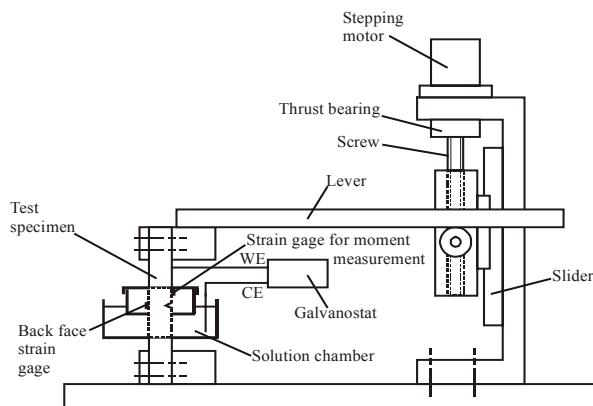
The test specimen is shown in Fig.1. It has a 2mm deep edge notch and 0.15mm deep fatigue pre-crack was introduced at the notch root in prior to test. The test equipment is shown in Fig.2. A lever is connected to the specimen and cyclic displacement was applied at the end of the lever which produced cyclic bending moment. The computerized stepping motor enabled the application of programmed loading.

Fig.1 Test specimen

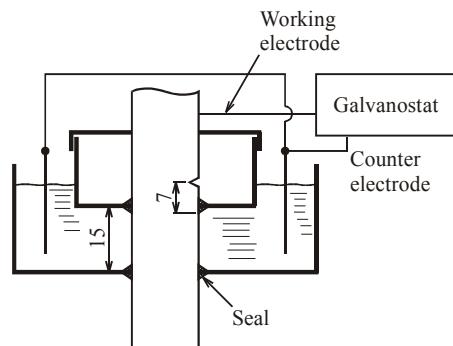
Fig.2 Test machine

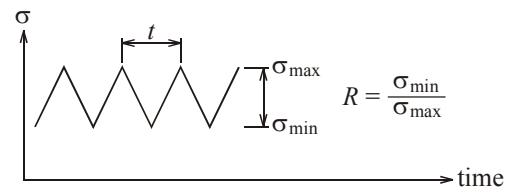
Crack propagation tests on material tempered at 843K which has medium strength and is popularly used in engineering application were done using triangular stress pattern shown in Fig.4. Loading period t was chosen as 1800s. Crack propagation rate is shown against stress intensity factor range ΔK in Fig.5. The crack propagation rate was accelerated by hydrogen absorption. At stress ratio lower than 0.4, moderate acceleration about six times occurred as shown by open symbols. At stress ratio

Fig.4 Triangular stress pattern

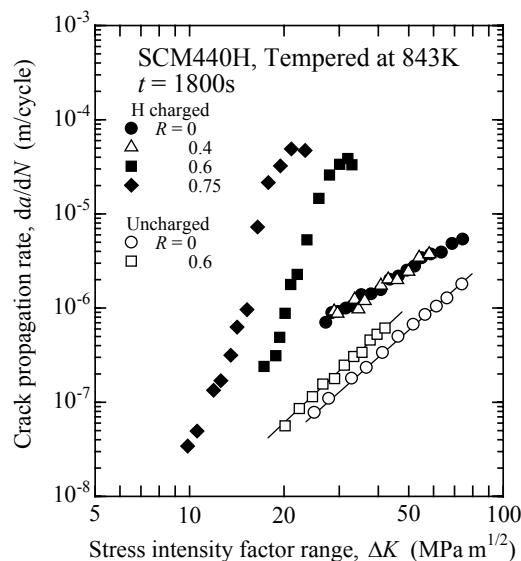
Fig.5 Effect of stress ratio on crack propagation rate under triangular stress shown against ΔK

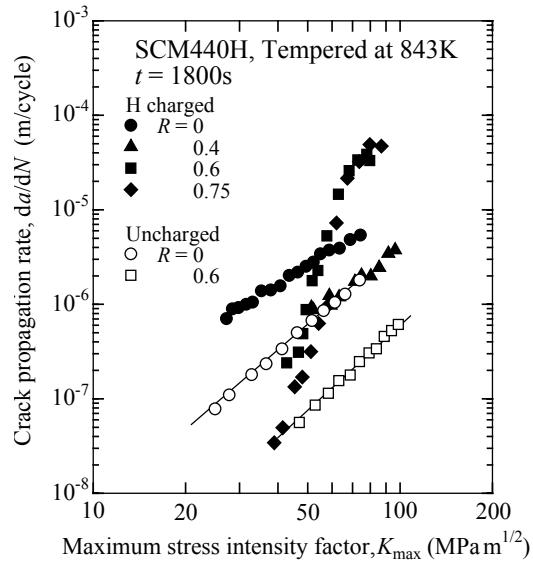
Fig.6 Crack propagation rate under triangular stress shown against K_{\max}

higher than 0.6, however, sudden acceleration appeared. The acceleration was about thousand times. The data were re-plotted against maximum stress intensity factor K_{\max} in Fig.6. The remarkably accelerated propagation rate data fell in a unique data band. The sudden acceleration was governed by K_{\max} , which indicates that the time-dependent crack growth mechanism is involved. The Vickers hardness of 843K tempered material was 325 which was lower than the usually accepted critical hardness for delayed failure.

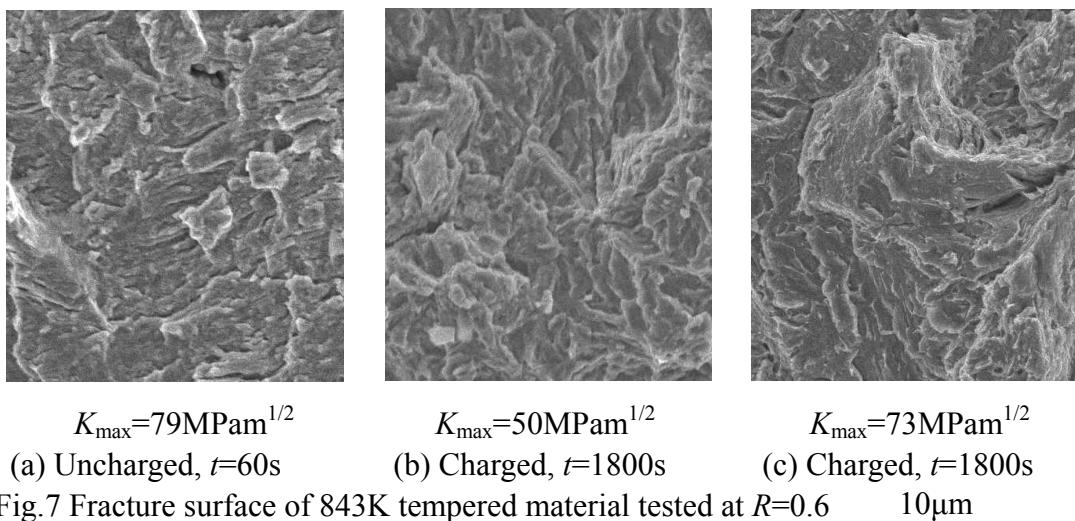
The fracture surface is shown in Fig.7. The morphology of uncharged material (Fig.a)

was striation mode. On the contrary, the morphology of hydrogen charged material which showed medium acceleration (Fig.b) as well as sudden acceleration (Fig.c) was quasi cleavage.

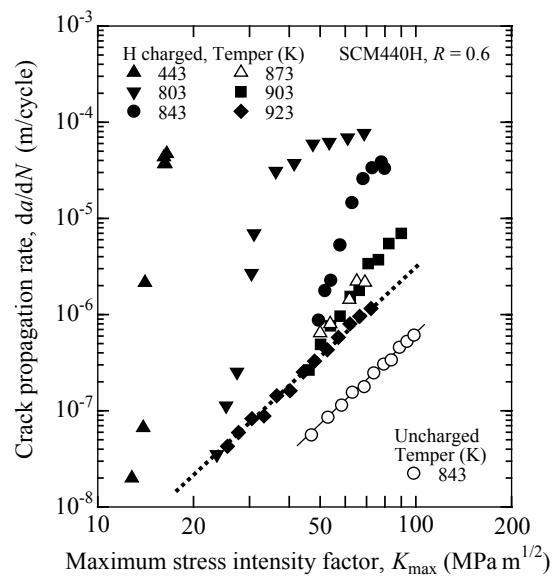
The effect of material hardness on the occurrence of sudden acceleration was examined using materials tempered at different temperatures. Test were done at $R=0.6$. Test results are shown in Fig.8. In all materials except 923K tempered material, sudden acceleration was observed. The fracture surfaces are shown in Fig.9. In the case of 403K tempered material

Fig.8 Effect of tempering temperature on acceleration of crack propagation at high stress ratio (triangular stress, $R=0.6$)

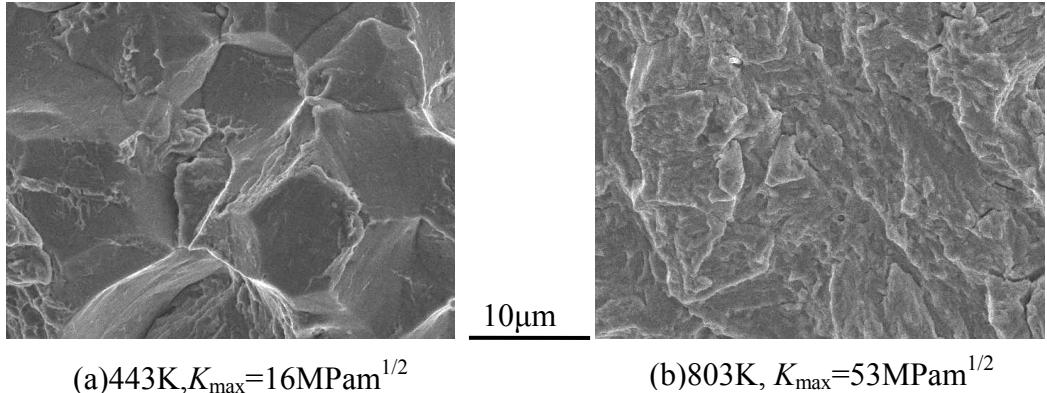
Fig.9 Effect of tempering temperature on fracture surface for triangular stress $R=0.6$, $t=1800s$

which is a very hard material, the morphology was intergranular. On the contrary, the morphology in other materials was quasi cleavage.

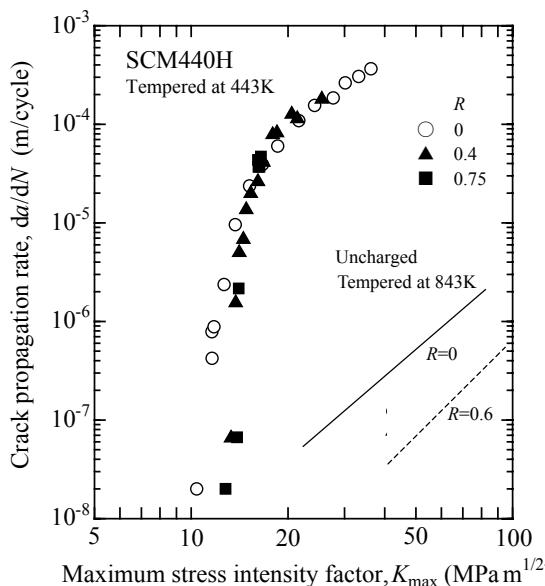
In the case of 843k tempered material which has medium strength, the sudden acceleration was experienced only at high stress ratio as shown above. This kind of acceleration is expected even at lower stress ratio in harder materials. Therefore, tests at various stress ratios including low stress ratio were done using 443K and 803K tempered materials. Test results are shown in Fig.10 and 11. Sudden acceleration was experienced at all stress ratios including $R=0$. The acceleration ratio compared to the

Fig.10 Effect of stress ratio on crack propagation of material tempered at 443K (triangular stress, $t=60s$)

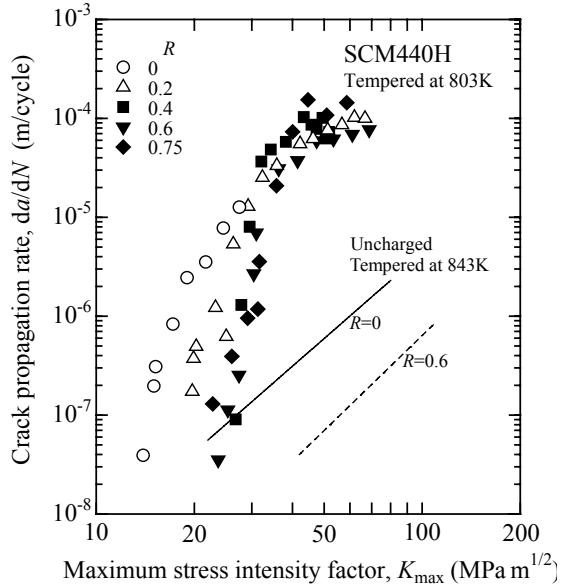
Fig.11 Effect of stress ratio on crack propagation of material tempered at 803K (triangular stress, $t=1800s$)

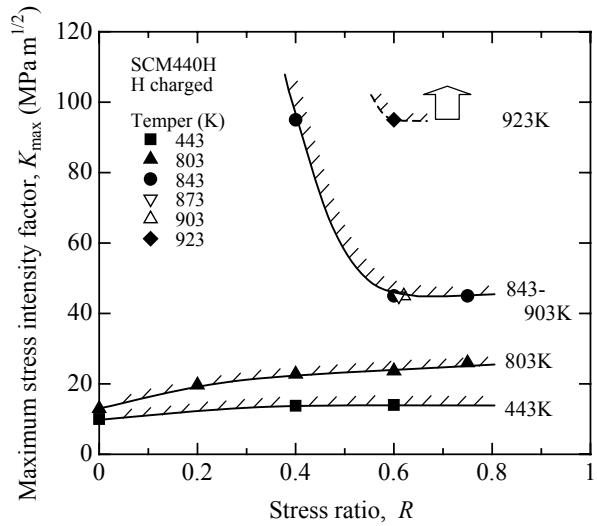
uncharged material was about one thousand. The critical condition map that caused sudden acceleration is shown in Fig.12. The acceleration was dependent on tempering temperature and stress ratio. Popularly used medium strength steel as well as hard material was enhanced by hydrogen. Soft material which was tempered at 923K was not enhanced by hydrogen.

Fig.12 Onset of acceleration of crack propagation under triangular stress

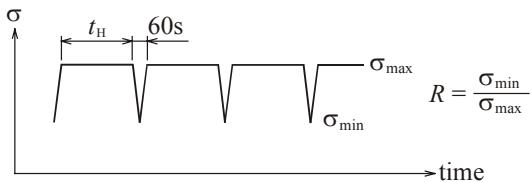
Crack propagation test using trapezoidal stress pattern shown in Fig.13 was done to examine the participation of time-dependent crack growth in the sudden acceleration. Test result is shown in Fig.14 for $R=0.6$. Hold time was

Fig.13 Stress pattern for time-dependent crack propagation

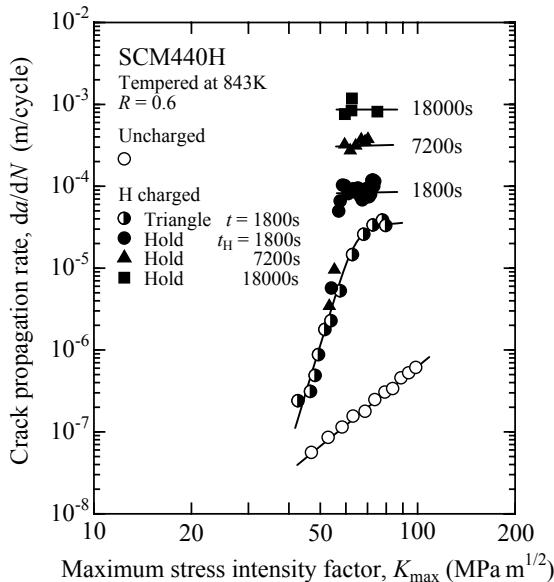
Fig.14 Time-dependent crack propagation in material tempered at 843K under stress hold

changed from 1800 to 18000s. The crack propagation rate per cycle showed plateau characteristic and the propagation rate at plateau was increased in proportion to hold time t_H , which suggests the involvement of time-dependent crack growth.

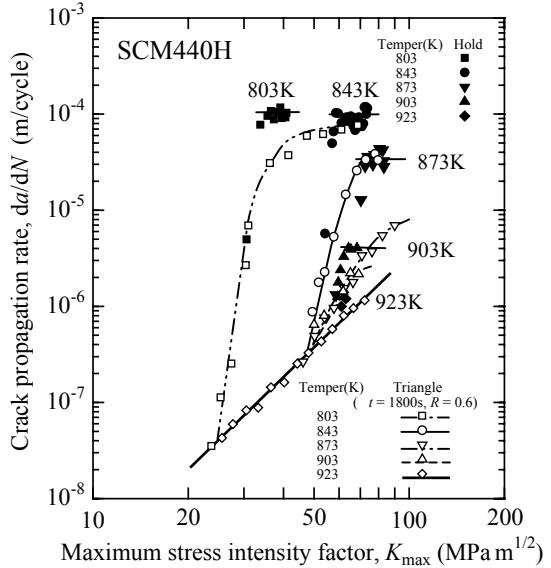
Fig.15 Effect of tempering temperature on time-dependent crack propagation under stress hold ($t=1800s, R=0.6$)

The effect of material strength on time-dependent crack growth was examined. Test result is shown in Fig.15. Stress ratio $R=0.6$ and hold time of 1800s were chosen. In all materials tested, crack propagation rate was increased by stress hold compared to the triangular stress pattern test shown by open symbols. Especially, materials which were tempered at lower than 873K showed large acceleration. Even in material tempered at 923K, small amount of acceleration was observed. The fracture surfaces are shown in Fig.16. The morphology was quasi cleavage. Harder material looks more brittle.

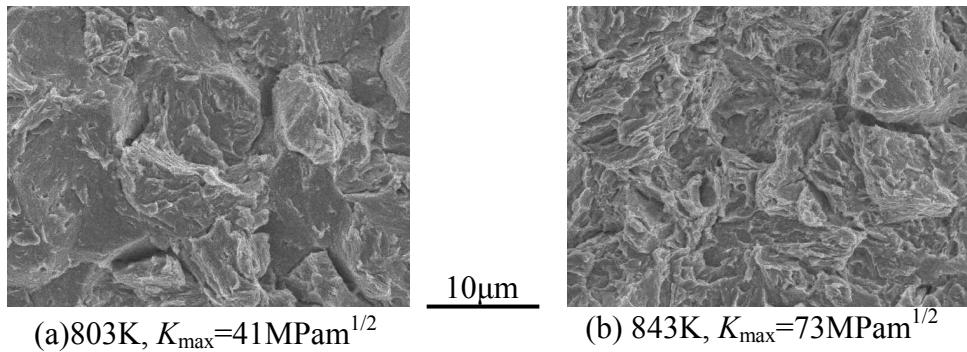
Fig.16 Effect of tempering temperature on fracture surface of time-dependent crack propagation under stress hold

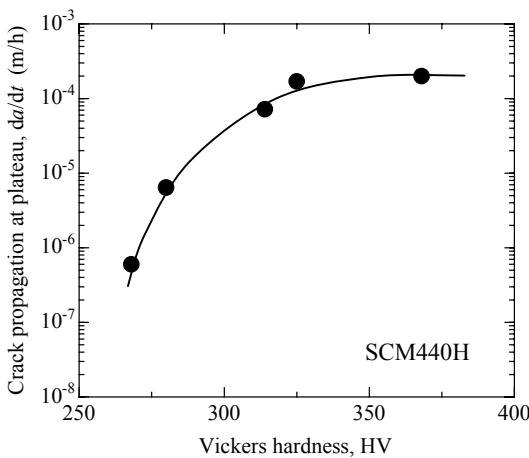
The effect of material hardness on plateau crack propagation rate is shown in Fig.17. The crack propagation rate is shown against material hardness HV. Even in material whose Vickers hardness was lower than the critical value for delayed failure (HV=350)

Fig.17 Effect of material hardness on time-dependent crack propagation rate

also showed crack propagation in the case of continuous hydrogen charged condition. In material with HV=268, the time-dependent crack growth was negligibly small [5]. The same data are plotted against tempering temperature in Fig.18. Time-dependent crack propagation rate could be substantially reduced by increasing the tempering temperature up to 923K.

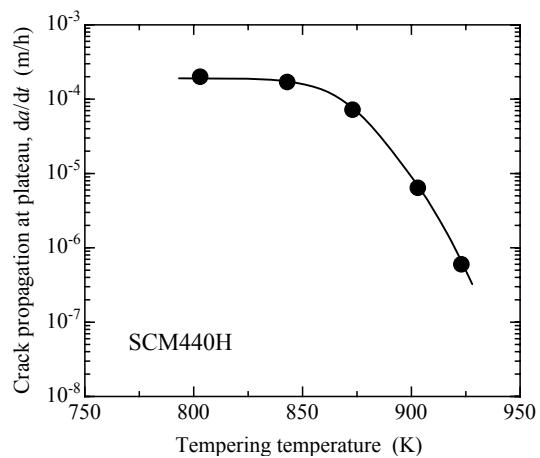
Fig.18 Effect of tempering temperature on time-dependent crack propagation rate
