Mechanisms of Internal Fatigue Fracture for a Low Alloy Steel under High Cycle Region at Elevated Temperatures

ABSTRACT: Stepwise S-N curves were obtained under rotating bending fatigue tests at elevated temperatures for an 1Cr-0.5Mo low alloy steel, as well as fatigue tests at room temperature for surface hardened specimens by shot peening or carburizing treatment. In the high cycle region, internal fracture with fish-eye pattern was dominant. Why internal fracture does occur at elevated temperatures for specimens of the low alloy steel without any surface hardening treatments? It has been pointed out that the existence of oxidized surface layer plays an important role to prevent cracks from initiating at the specimen surface. But any evidence verifying the effect of oxidized surface layer on fatigue behavior has not been obtained. The steel used was hardened remarkably under cyclic stressing at intermediate temperatures due to dynamic strain aging. It is considered to be difficult for Stage II crack to initiate at specimen surface, because the slip bands hardens gradually during fatigue test at elevated temperature. This process has to bring the same effect as surface hardening

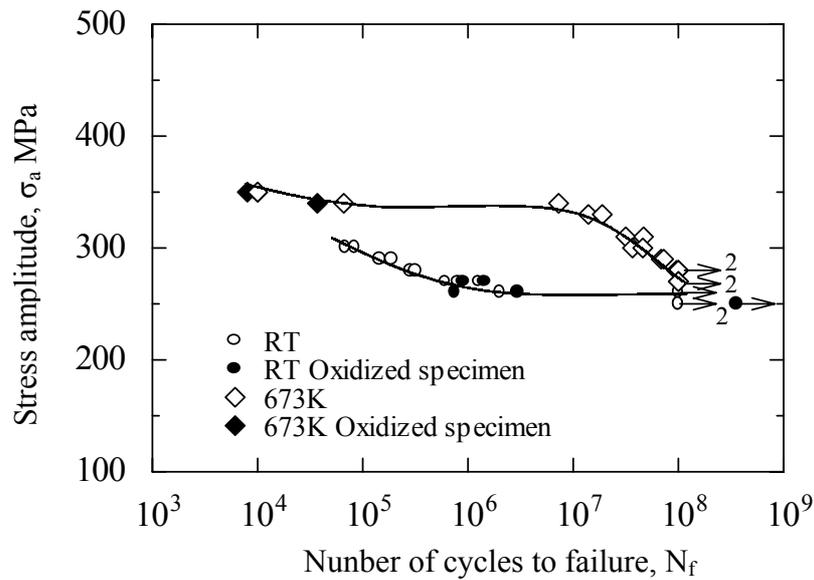
Figure 1 Rotating bending fatigue S-N curves and effect of oxidized surface layer on fatigue strength

Figure 1 shows conventional and stepwise S-N curves obtained for the present material at room temperature and 673K, respectively [4]. Under low stress levels of stepwise S-N curve, fatigue crack initiated at interior of the specimen and fish-eye pattern was observed on the fracture surface. It has been pointed out [1] that the existence of oxidized surface layer plays an important role to prevent cracks from initiating at specimen surface. That is, as the oxidized surface layer prevents dislocations from going out through surface, Stage I cracks cannot be formed at specimen surface, and then fish-eye fracture occurs by the initiation and propagation processes of internal crack.

To clarify this assumption, fatigue tests were carried out at 673K and room temperature for specimens with oxidized surface layer, which specimens were exposed at 673K for 5 days before the fatigue tests. The results are shown in Figure 1. The fatigue lives scarcely changed compared

with those for specimens without previous oxidized surface layer at both temperatures. According to the observations of the fracture surfaces, fatigue cracks initiated at the specimen surface and no fish-eye pattern was observed. These results suggest that oxidized surface layer itself has no effect on preventing fatigue crack from initiating at the specimen surface.

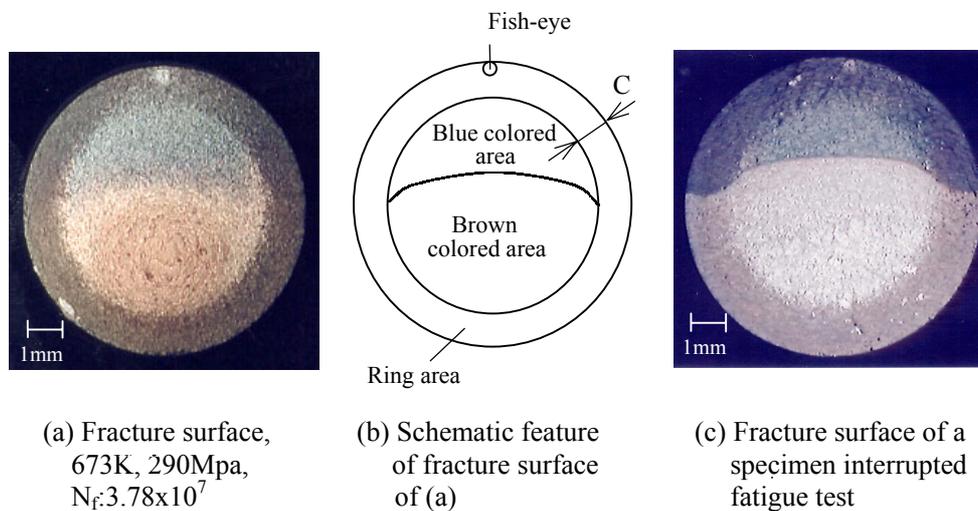
Figure 2 Pattern of fracture surface with fish-eye.

On fracture surfaces fatigued under low stress levels at 673K, not only fish-eye pattern but also a characteristic feature were observed macroscopically, as shown in Figure 2(a). The fracture surface can be divided into three parts, that is, a ring area including fish-eye for a certain depth from specimen surface, blue colored area and brown colored area as shown in Figure 2(b) schematically. Mean value of roughness of the ring area is $4\mu\text{m}$, and those of the blue and brown areas are $12\mu\text{m}$ and $34\mu\text{m}$, respectively. The brown area where is the roughest of all seems to be the final fracture region.

Figure 2(c) shows a fracture surface, which fatigue test was carried out at 673K, and interrupted just before final fracture. The final fracture was brought by test at room temperature. The front of crack growing at high temperature can be recognized clearly. This picture indicates that the boundary of the ring area is not a crack front at a certain time and that crack propagates underneath the surface with priority after formation of fish-eye. The ring area was recognized continuously on the fracture surfaces formed at 673K and at room temperature.

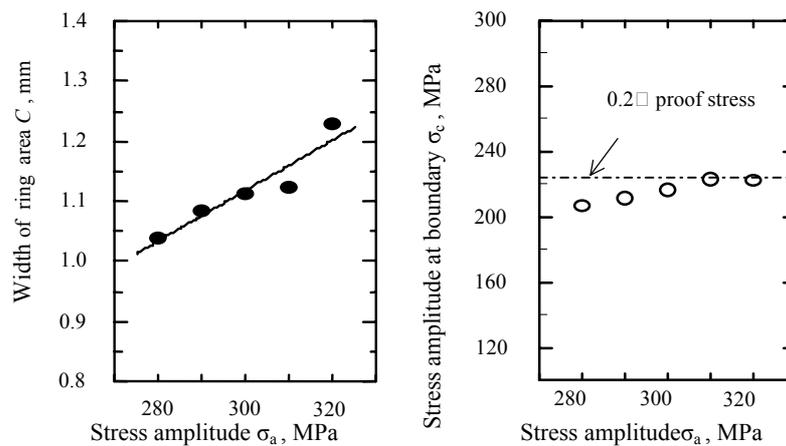
Figure 3 Relationship between width of ring area and stress amplitude, and stress amplitude at boundary of ring area

Figure 3 shows that the width of the ring area C increased with increasing stress amplitude of tests and that the value of stress amplitude applying at boundary of the ring area was the same as 0.2% proof stress approximately for the present material at 673K. This result means that a region of the ring area was exposed to cyclic strain amplitude including a plastic strain component.

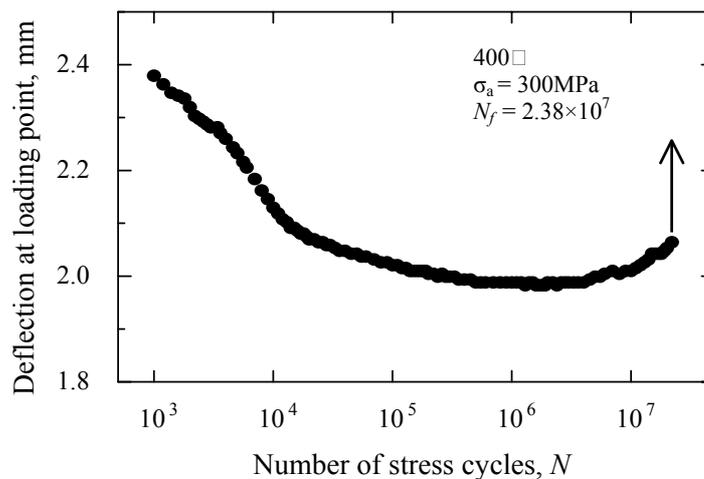
Figure 4 Change in deflection at loading point with increasing number of stress cycles.

It has been reported that 1Cr-0.5Mo steel the same as the present material hardens remarkably under uniaxial low cycle fatigue conditions at intermediate temperatures due to dynamic strain aging [5]. It is difficult to measure directly the strain on the surface of specimen under rotating bending. But, behavior of cyclic hardening under rotating bending conditions can be confirmed by measuring a change in deflection at loading point during fatigue test. Decrement of the deflection at loading point means the specimen hardens under cyclic stressing. Figure 4 shows an example of the change in the deflection at loading point with increasing number of stress cycles. The deflection at loading point decreased up to cycles of order of 10^7 , and then it increased gradually. It is not clarify what

kinds of mechanisms correspond with the change in the deflection at loading point, but the results indicates that present material hardens during early stage of rotating bending fatigue conditions at 673K.

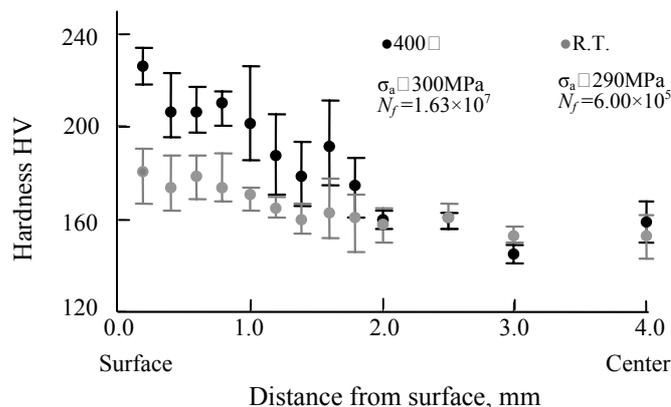
Figure 5 Hardness distribution measured at cross section of fatigued specimen.

Figure 5 shows the results of observation of hardness at cross sections of a specimen with fish-eye pattern tested at 673K and a specimen fatigued at room temperature. Hardness of a region underneath the surface increased strikingly for the fatigued specimen at 673K. This result suggests that the ring area was a region hardened during fatigue test.

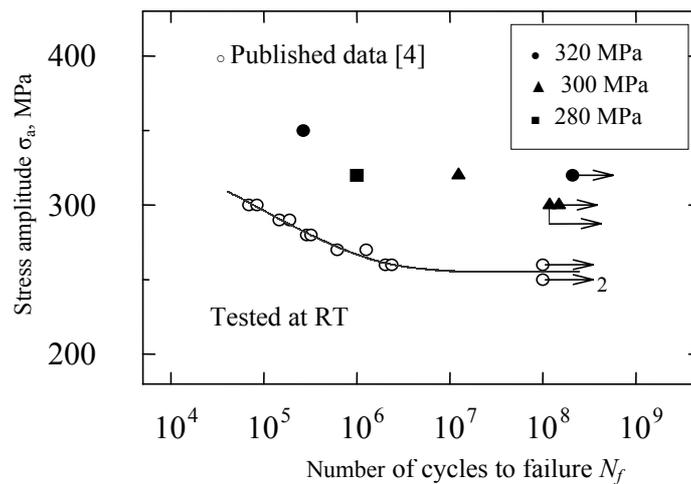
Figure 6 S-N plots for pre-fatigued specimens at 673K.

To verify this assumption, pre-fatigued specimens at 673K under stress amplitudes of 280 to 320 MPa for 10^7 cycles were prepared and then fatigue tests were carried out. As shown in Figure 6, fatigue strength and fatigue lives improved drastically. It should be noticed that the improvement depends on pre-fatigue conditions. For example, in fatigue test at room temperature for a pre-fatigued specimen at 673K under 300 MPa for 2.6×10^7 cycles, fish-eye fracture occurred and improvement in fatigue strength was not recognized.
