A Study of Post Plating Heat Treatment in Automotive Fastener Steels

ABSTRACT: *In the automotive industry many high strength steel fasteners are zinc electroplated. The plating process is thought to be a principal cause of hydrogen embrittlement: fasteners can fail unpredictably at applied stress levels well below the fracture stress. To avoid this a hydrogen relief heat treatment after electroplating is commonly applied. In this study the effect of plating and post-plating treatments on the slow strain rate tensile fracture behaviour of two commercial steels has been investigated. Testing was conducted on fatigue pre-cracked cylindrical specimens in air. Results describing the effect of alloy selection, metallurgical processing conditions and heat treatment on the susceptibility to hydrogen embrittlement are presented. The principal conclusion drawn from this study is that post-plating hydrogen relief annealing, as specified by international standards, is not always of benefit.*

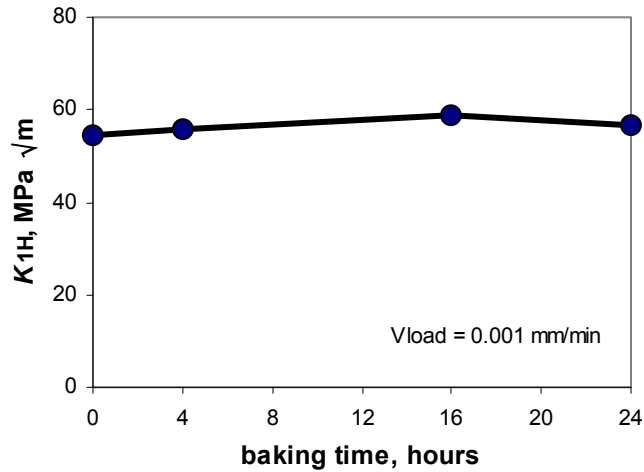
Figure 2: Effect of the baking time on the threshold stress intensity factor for hydrogen embrittlement in Steel A.

Attempts to reduce the embrittlement by extending the time of baking have been made. The results of tests conducted on samples from the Steel A indicate that extended baking up to the 24 hours yields little effect on threshold stress intensity factor (Figure 2).

The baking treatment applied according to the standard recommendations for high strength fastener steels is ineffective in reducing the hydrogen embrittlement. Extending the baking time up to 24 hours produced no effect on the embrittlement of the steels investigated.
