# CRACK INITIATION MECHANISM OF BEARING STEEL IN VERY HIGH CYCLE FATIGUE

## ABSTRACT

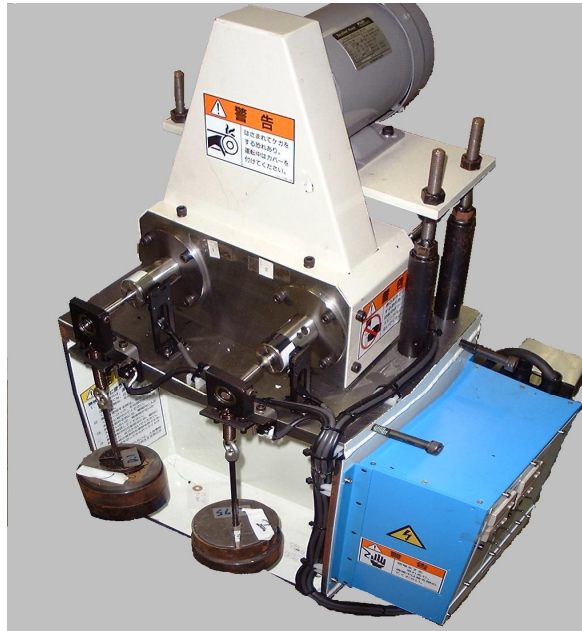
Fatigue tests in rotating bending were performed in the ordinary room atmosphere without control of the temperature and the humidity by means of a dual-spindle testing machine as shown in Figure 2. This machine was originally developed by the authors in order to perform fatigue tests in very high cycle regime within the reasonable testing period. Fatigue tests of four specimens can be performed simultaneously by this machine. The rotating speed of the specimen was 3150rpm. The detailed structure and the performance were indicated in their earlier works[1,10].

Figure 2. Dual-spindle fatigue testing machine in rotating bending

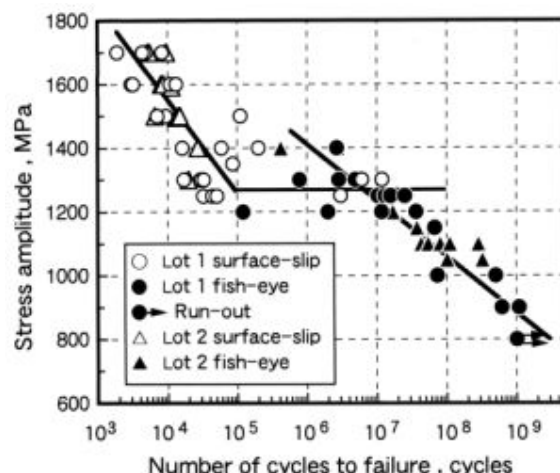
Fatigue test data of SUC2 steel obtained in the gigacycle regime were plotted as an S-N diagram in Figure 3. Fatigue tests were conducted for specimens prepared from two different lots of the same steel. The fracture surface of every failed specimen was observed by FE-SEM in order to distinguish the fracture modes of the surface induced fracture and the

interior-inclusion induced fracture. Open marks in Figure 3 indicate the results in the surface induced fracture, whereas solid marks the results in the interior-inclusion induced fracture. A clear knee point was found at  $N=10^5$  in the S-N curve for the former fracture mode, but we have another S-N curve for the latter fracture mode. Thus, it was found that the complicated fatigue property of this steel can be well interpreted as the "Duplex S-N characteristics" consisting of the respective fracture modes. This aspect in the rotating bending fatigue tests was repeatedly confirmed by many researchers[1,10,14-16]. However, existence of the fatigue limit in the interior-inclusion induced fracture was not confirmed yet, even if fatigue tests were carried out toward the gigacycle regime.

Figure 3. S-N diagram of SUJ2 steel.

- (1) Significant duplex *S-N* curves consisting of those for the surface induced fracture and the interior-inclusion induced

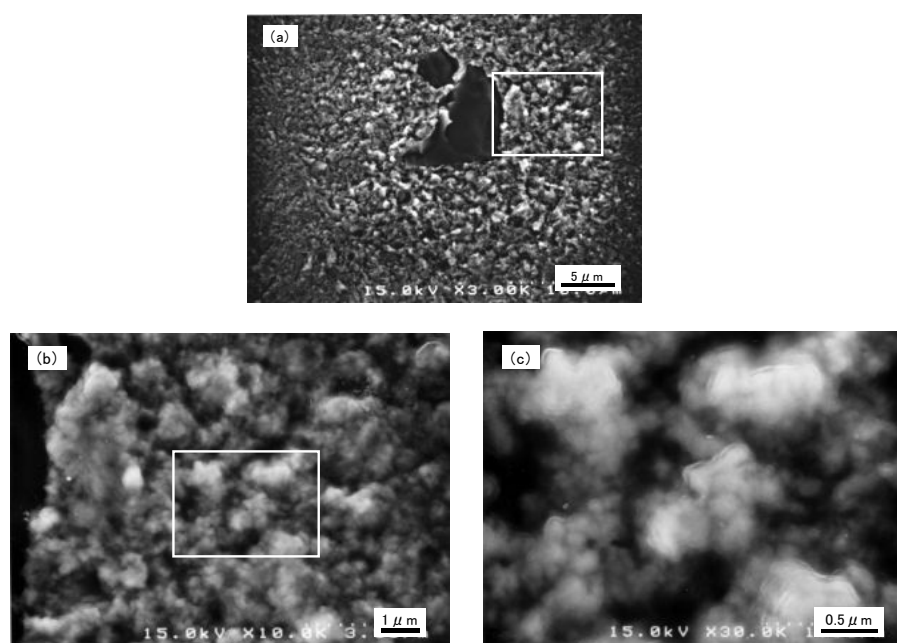
Figure 4 shows an example of Field Emission Scanning Electron Microscope(FE-SEM) images at the center of a fish-eye on a fracture surface of specimen failed in the interior-inclusion induced fracture( $\sigma_a = 1100$  MPa,  $N=2.85 \times 10^8$ ). A non-metallic inclusion was observed at the center of the fish-eye. This non-metallic inclusion was analyzed to be TiN. The Fine Granular Area(FGA) was clearly observed around the inclusion. Thus, the fracture surface in the FGA has a distinct roughness as reported in the authors' earlier papers[1,6,10,12] and some papers by other researchers[14,16]. Figure 4(b) indicates the high magnification image of the area enclosed by the white square frame in Figure 4(a). In

Figure 4. FE-SEM images in the vicinity around non-metallic inclusion

addition, an area enclosed by the white square frame in Figure 4(b) was again observed in the higher magnification and the image was indicated in Figure 4(c). One can well trace the morphology of the fracture surface in each image in Figure 4(a), (b) and (c), respectively.

Fracture surface of the opposite side of the same failed specimen was similarly observed by FE-SEM. Thus, we found that the white portion inside the FE-SEM image is beautifully corresponding to the dark portion of the opposite fracture surface. By performing such matching observations for a pair of fracture surfaces, it was found that a concave portion of a fracture surface well corresponds to the convex portion of the opposite fracture surface of the same specimen. This fact suggests that the separation of microscopic curved boundaries is more instructive rather than the formation of micro-voids, since such voids have to produce concave morphology at both sides of the fracture surface.

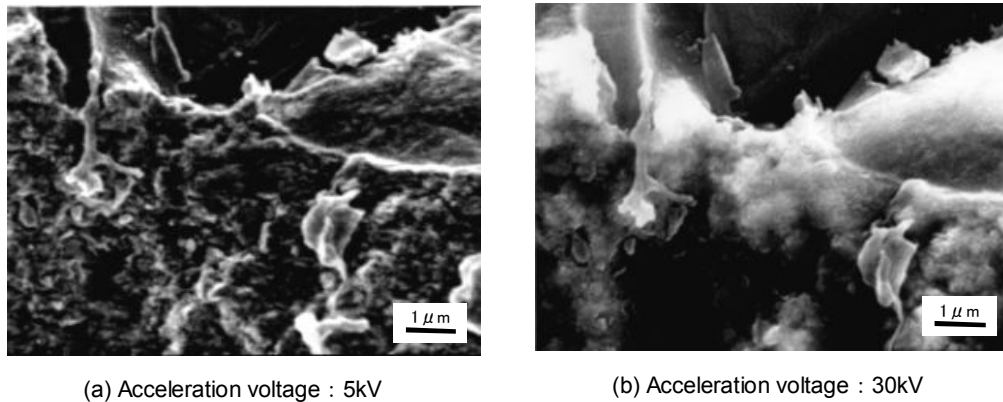
In FE-SEM observations of the fracture surface, the authors had noticed an interesting aspect that a distinct difference was found in the images observed in the different acceleration voltages. Figure 5 shows the FE-SEM images of the FGA thus observed by different voltages. Figure 5(a) indicates the result observed at 5kV of the acceleration voltage, whereas Figure 5(b) the result obtained at the different voltage of 30kV. In the case of 5kV, the electron penetrating depth is shallow comparing with the corresponding depth at the voltage of 30kV. From this point of view, FE-SEM image at the higher voltage provides an image reflecting the microstructure of the surface layer having a sufficient thickness, but the image at the lower voltage provides the corresponding image reflecting the microstructure of only very thin surface layer. If the microstructures in the very shallow surface layer and a little deep layer are the quite same, both FE-SEM images would come close to each other. However, if the microstructures of the shallow surface layer and the deep layer have a distinct difference, FE-SEM images obtained by different acceleration voltages should be reflected distinctly. In other words, if a distinct difference was found between two FE-SEM images taken at different voltages, then a marked difference would be caused in the microstructure in each layer. This fact suggests that the microstructure of very shallow layer is distinctly differ from that of a little deep layer. As mentioned above, the fine granular morphology can be observed around the inclusion on the fracture surface, but such a characteristic morphology cannot be found in the other area. Accordingly, it should be noted that the extensive polygonization can take place within only very shallow surface layer inside the FGA.

Figure 5. FE-SEM images of FGA observed at different acceleration voltage.

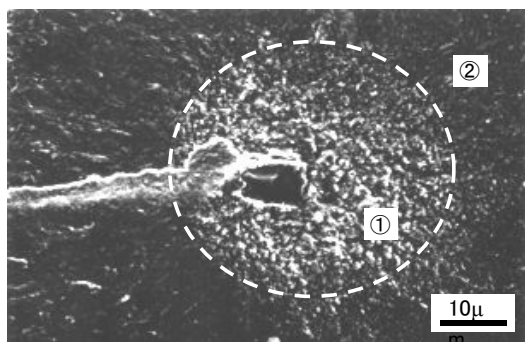
Figure 6 indicates an example of FE-SEM image around a non-metallic inclusion at the crack initiation site of a specimen failed at  $\sigma_a = 900 \text{ MPa}$  and  $N = 1.08 \times 10^9$ . A clear area of FGA surrounded by a dotted circle was observed and the morphology inside the FGA is quite similar to that in Figure 4(a). This feature inside the FGA is very common in the crack initiation site for every specimen failed in the interior-inclusion induced fracture mode. In order to examine a microstructural change of the surface layer of the FGA, the longitudinal section of the fracture surface was observed by means of a scanning ion microscope(SIM). The longitudinal section of the FGA was carefully produced by gallium ion sputtering technique using a focused ion beam system(FIB).

Figure 6. An example of FE-SEM image of FGA on fracture surface.

At first, the longitudinal section at the position of (1) inside the FGA in Figure 6 was observed by SIM, and the result was shown in Figure 7(a). Another position (2) outside the FGA was also observed by the same technique and the photograph was given in Figure 7(b). The top edge of each image provides the fracture surface of position (1) or (2) in Figure 6. Comparing these two photographs with each other, one can find that the microstructure in a thin surface layer of the fracture surface in Figure 7(a) becomes fine granular, but such a fine granular region was not observed in the microstructure in Figure 7(b) corresponding to the position of (2) outside the FGA. Paying a particular attention to the top edge of the section in Figure 7(a), the fine granular area was not spread throughout the FGA surface. The fine granular layer is observed in the limited area in the fracture surface inside the FGA. This fact suggests that the some parts of the fine granular layer are adjoining with the fracture surface of the present half specimen and other parts of the fine granular

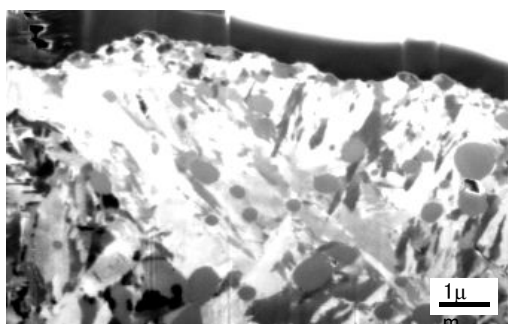
layer are remaining at the fracture surface of the opposite half specimen. In other words, the fine granular layer is induced around a non-metallic inclusion inside the material during the long-term sequence of stress cycles and a pair of boundaries between matrix and this thin layer tend to debond depending on the boundary strength. If the debonding occurs at the top boundary of the fine granular layer, the thin layer is kept on the bottom specimen, but the layer is kept on the top specimen when the debonding takes place at the bottom boundary. In this manner, some parts of the fine granular layer are remaining on the top specimen, while some other parts of the layer are on the bottom specimen. However, such a phenomenon is not observed outside the FGA, since the fine granular layer is no longer induced in this area.

(a) Inside FGA : part① in Figure

Figure 7. SIM image of longitudinal section of fracture

The microstructure inside the fine granular area(FGA) in Figure 7(a) was again observed by a transmission electron microscope(TEM). The TEM specimen was prepared by means of a special technique of Focused Ion Beam System(FIB), and thickness of this specimen was 30nm, approximately. A bright field image of TEM observation thus obtained is given in Figure 8. The mark of A indicates the fine granular layer inside FGA, whereas the other mark of B is indicated at the deep position where the fine polygonization was not observed. X-ray diffraction patterns at areas A and B in Figure 8 are indicated in Figure 9(a) and (b), respectively. The diffraction pattern at area of A in Figure 8 gives a ring-like pattern, while

The ring-like pattern in Figure 9(a) is given when a number of subgrains are participating in the diffraction at very limited area, whereas the spot-like pattern in Figure 9(b) is obtained from a definite crystal depending on the crystal structure. From this point of view, one can conclude that a lot of fine subgrains having different crystal orientations are produced within the thin layer around the non-metallic inclusion during a number of stress cycles. Thickness of this fine granular layer having the characteristic feature is within 400nm as seen in Figure 8. This value is well corresponding to the thickness of the fine granular layer to be observed in Figure 7(a).

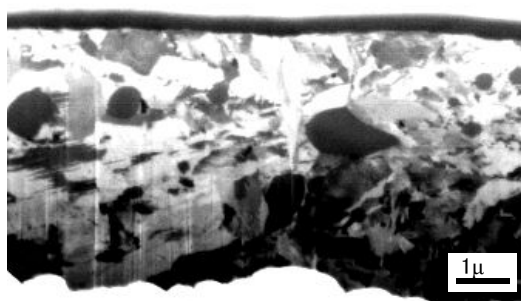
(b) Outside FGA : part② in Figure

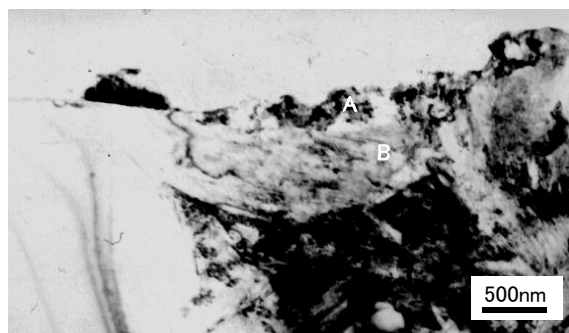
Figure 8. TEM image of longitudinal section of FGA in bright field

the corresponding image at area of B in Figure 8 provides the spot-like pattern peculiar to the martensitic structure of this steel.

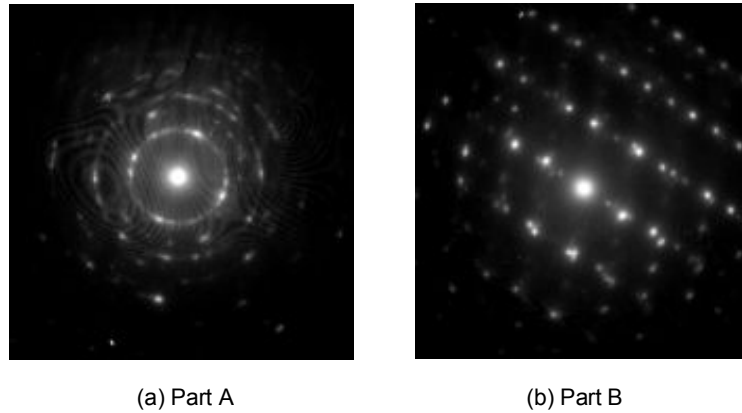
Figure 9. Selected area X-ray diffraction patterns in thin layer and deep position.

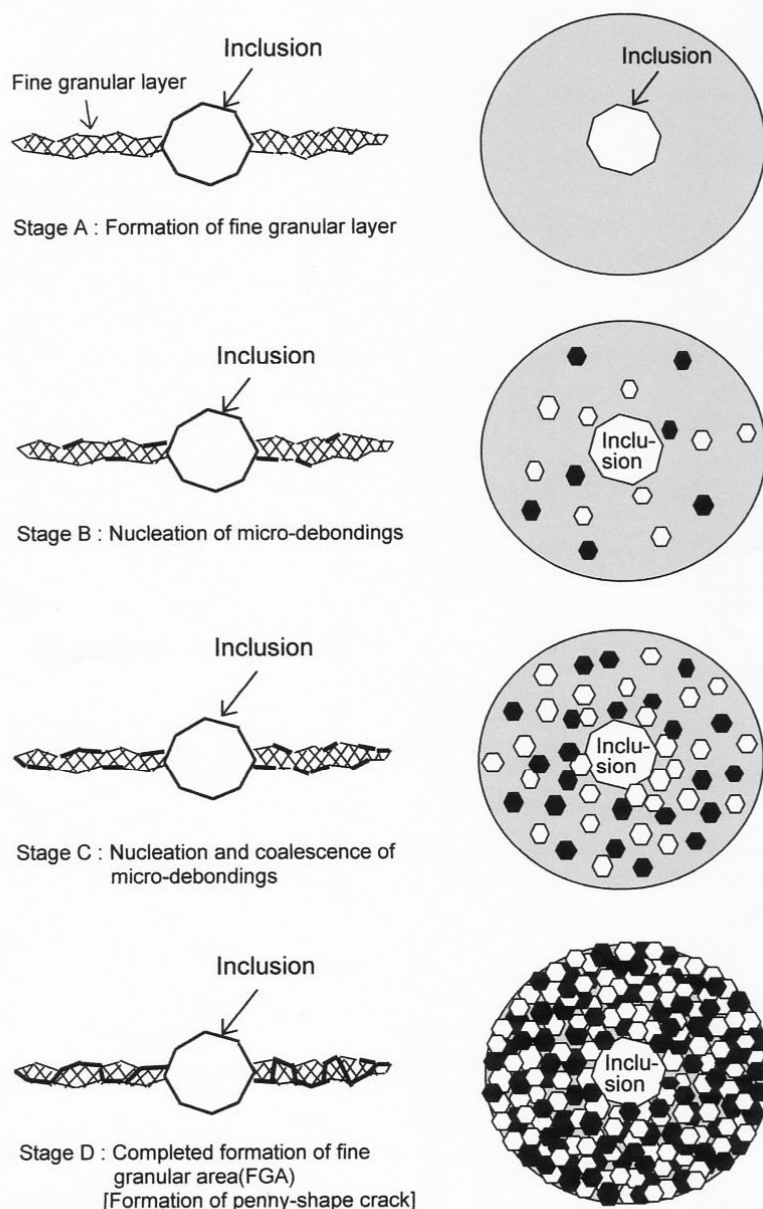
As shown in the previous section, the authors have observed the microstructure inside the fine granular area(FGA) for several specimens by using the same procedure, and common results are obtained for every observation. Thus, the characteristic area of FGA around the non-metallic inclusion at the crack initiation site is a common feature in the very high cycle fatigue. Based on the microscopic observations by FE-SEM and SIM together with the analysis of X-ray diffraction patterns of the microstructure, mechanism of the fatigue crack initiation in the very high cycle regime would be assumed to have following four stages as illustrated in Figure 10.

- Stage A : a fine granular layer caused by the intensive polygonization is gradually induced around the interior-inclusion during a long sequence of the cyclic loading. [Formation of fine granular layer]
- Stage B : microscopic debondings take place along the boundaries between the fine granular layer and the matrix of the material depending on the strength level at each site of the boundaries. [Nucleation of micro-debondings]
- Stage C : number of micro-debondings is increased gradually and some of them would coalesce to one another. [Nucleation and coalescence of micro-debondings]
- Stage D : micro-debondings are entirely spread over the fine granular layer and the penny-shape crack is finally formed around the interior-inclusion of the material. [Completed formation of the fine granular area(FGA)]

In Figure 10, the longitudinal sections passing through the inclusion at the crack initiation site are indicated in the left hand side, while the cross sections passing through the same inclusion are given in the right hand side, respectively. Some segments of thick solid lines in the left hand side indicate the micro-debondings along the boundaries between the fine granular layer and the matrix of the material. Thickness of the fine granular layer is within 400nm. At the final stage(Stage D), all the segmentations are adjoined to one another by penetrating the fine granular layer so that a rough surface area is produced as the fine granular area(FGA). White spots in the illustrations of the right hand side indicate micro-debondings along the top boundary, whereas black spots provide the micro-debondings along the bottom boundary. Thus, all of these white and black spots are adjoined at the final stage of the crack initiation(Stage D), and the penny-shape crack is produced around the inclusion. Based on this mechanism, the significant morphology to have the distinct rough surface is produced inside the FGA. In this manner, the characteristic area of FGA is produced in the long sequence of the cyclic loadings in the very high cycle fatigue. As reported in the earlier works[17,18], once the crack size exceeds the critical size giving the threshold value for the fatigue crack propagation at the FGA front, the fatigue crack tends to grow by each cycle of the applied load as governed by the Paris' law of the fatigue crack propagation[19],

Figure 10 Illustration of fatigue crack initiation process in the interior-inclusion induced fracture in very high cycle fatigue

- (2) Characteristic area of fine granular area(FGA) was necessarily formed around the inclusion at the crack initiation site. By performing some matching observations for a pair of fracture surfaces, debondings of microscopic curved boundaries in the FGA was caused as the crack nucleation process instead of the formation of micro-voids.
- (3) Based on FE-SEM and TEM observations together with X-ray diffraction analysis, it was found that the fatigue crack in very high cycle fatigue was caused through the following mechanisms; Stage A(Formation of fine granular layer around an inclusion), Stage B(Nucleation of micro-debondings), Stage C(Nucleation and coalescence of micro-debondings) and Stage D(Formation of penny-shape crack).
