# THE CORROSION-INDUCED FRACTURE TOUGHNESS DEGRADATION OF ARTIFICIALLY AGED 2024 ALUMINUM ALLOY SPECIMENS

## ABSTRACT

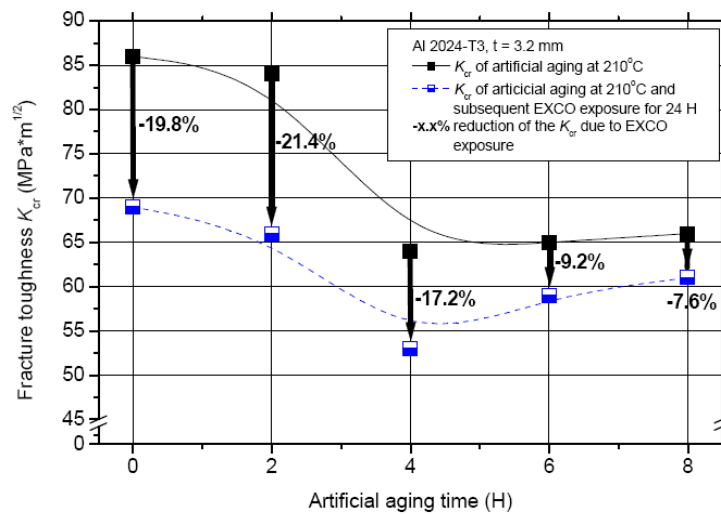
**Fig.3:** Calculated fracture toughness  $K_{cr}$  values based on the nominal thickness of  $t = 3.2$  mm of the 2024-T3 alloy.

The fracture toughness test results for the various artificial aging conditions are presented in Figure 3. The  $K_{cr}$  values were calculated based on the nominal thickness  $t = 3.2$  mm of the alloy. A significant decrease is noticed for increasing artificial aging of the alloy. From the reference value of  $86 \text{ MPa}\cdot\text{m}^{1/2}$ , values up to  $65 \text{ MPa}\cdot\text{m}^{1/2}$  for the (OA) condition were recorded. It was eminent that the subsequent exposure to the corrosive environment would further decrease this property; for the cases of (UA) condition (0 h and 2 h artificial aging) and the (PA) condition (4 h artificial aging), a large reduction of almost 20% on the  $K_{cr}$  due to EXCO exposure is noticed, Figure 3. At the (OA) condition (6 h and 8 h) the  $K_{cr}$  values decreased by only 9.2% and 7.6%, respectively, due to the corrosion exposure.

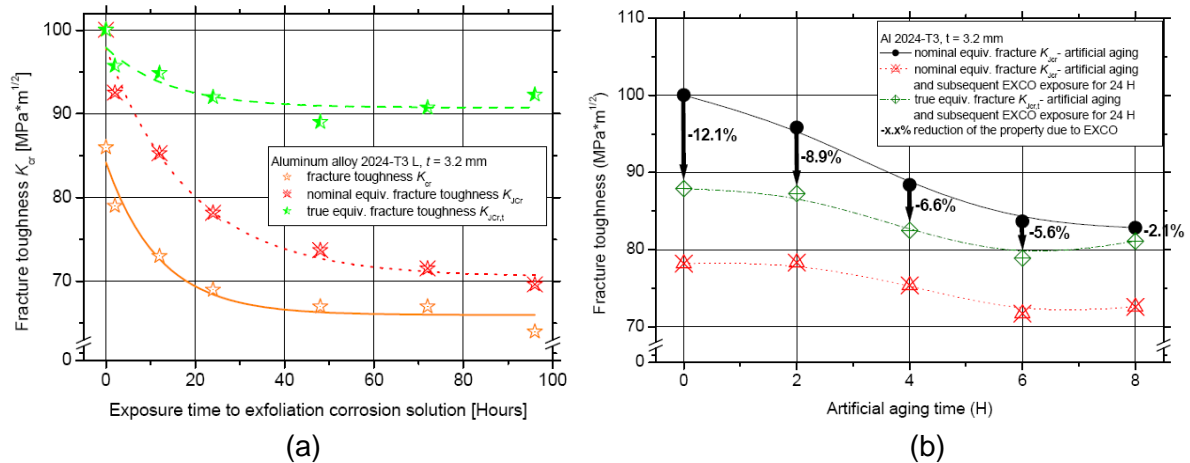
**Fig.8:** (a) Calculated fracture toughness values for the various exposure times of aluminum alloy 2024-T3 to the exfoliation corrosion solution and (b) fracture toughness results calculated for the nominal and true (or effective) thickness of the specimen.

Figure 8a shows the phenomenological (nominal) as well as the true fracture toughness values of the specimens. The true fracture toughness values (calculated based on the effective thickness of the material) seems to be saturated after only 24 h of exposure. By further exposing the alloy to the corrosive environment, its true fracture toughness does not decrease, on the contrary to the nominal fracture toughness. Hence, the total reduction of almost 30% of the fracture toughness after 96 h exposure to exfoliation corrosion solution is attributed primary to the reduction of the alloy's effective thickness (22%) and secondary to the hydrogen embrittlement (8%) mechanism.

Likewise, the fracture toughness test results of the different artificial aged specimens have been re-calculated to take into account the effective thickness, Figure 8b. Bearing in mind that the reduction of the specimen's thickness has been already taken into account, the decrease in fracture toughness is attributed either to hydrogen embrittlement or to the stress concentration of the corrosion-induced surface cracks. With increasing aging time, the 24 h EXCO exposure seems to have a lower impact on the fracture toughness degradation. For the increasing aging time, the decrease is of the order of magnitude of 6%, e.g. 4 h and 6 h artificially aged specimens, while for the (OA) alloy of 8 h, the decrease of the fracture toughness is only 2%.
