AE monitoring and structural modeling of the Asinelli Tower in Bologna

Alberto Carpinteri¹, Giuseppe Lacidogna^{1,*}, Stefano Invernizzi¹,
Amedeo Manuello¹

¹ Department of Structural, Geotechnical and Building Engineering, Politecnico di Torino, 10129, Torino, Italy.

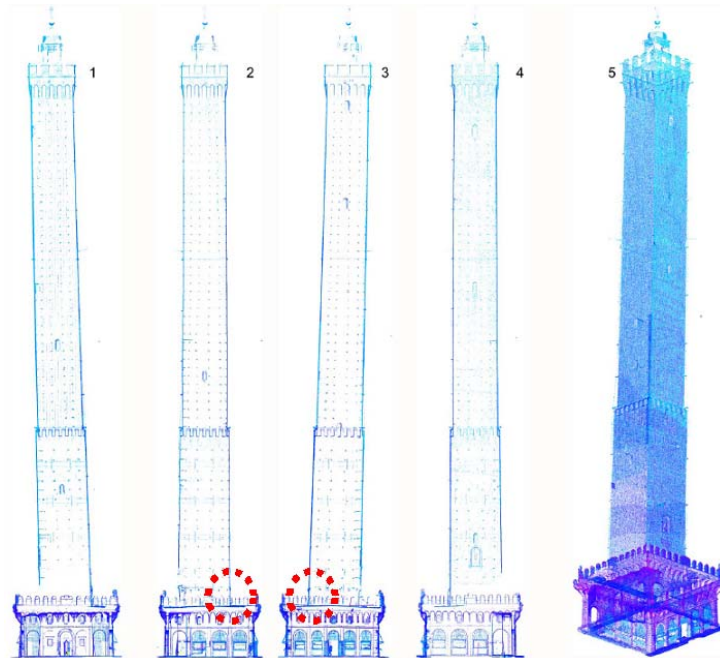
Figure 2. Front views and axonometric view of the Torre degli Asinelli. These views, supplied by the Municipality of Bologna, are taken from the measurements of the exterior of the structure made by Prof. Alessandro Capra by laser scanning. Faces (1) South; (2) East; (3) North; (4) West; (5) Axonometric view. The transducers were applied to the north-east corner of the tower, in the zones marked with a circle.

The studies conducted in the early twentieth century by F. Cavani [8] revealed that the Asinelli Tower leaned westward by 2.25 m; this is the reason why it is known as the tallest leaning tower in Italy. The latest measurements, made in 2009 by Prof. A. Capra by laser scanning, on behalf of the municipality, showed an overall inclination of 1.51 degrees and a deviation from verticality of 2.38 m. Thus we find that the deviation increased by 13 cm in the course of approx. one century, that is to say at an average rate of 1.30 mm/year. Figure 1 shows the Asinelli Tower and the adjacent Garisenda Tower in the city centre of Bologna. Figures 2 and 3 show the front elevations and the cross-section of the Asinelli Tower and a plan view indicating the zone of application of the AE sensors.

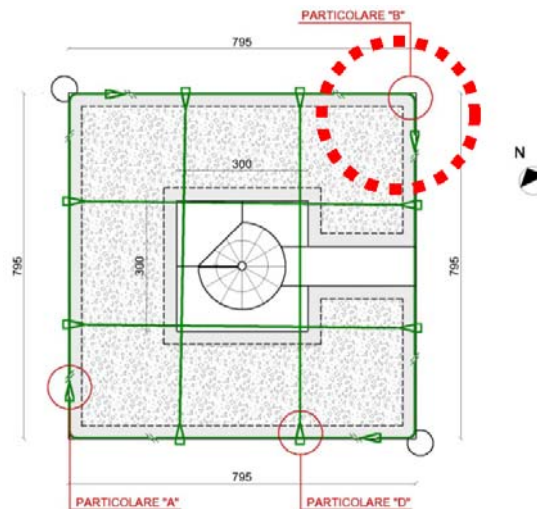
Figure 3. Cross-section of the tower at a height of ca 10 m above ground. Drawing supplied by the Municipality of Bologna. The corner where the sensors were applied is marked with a circle.

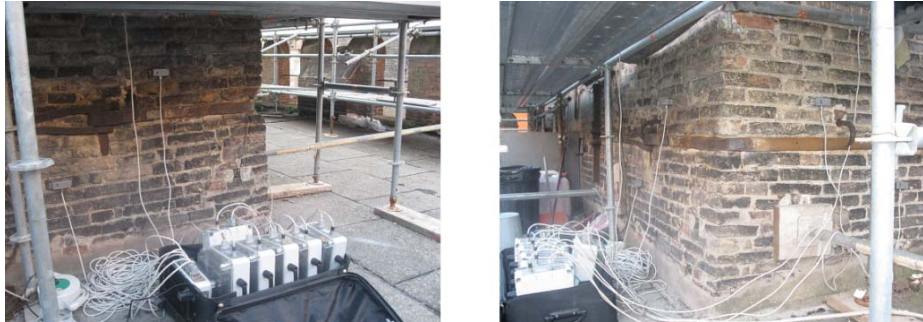
Figure 4. Photos of the AE data acquisition system on the monitoring site.

Only a limited number of sensors were available and hence the AE devices were positioned in a zone that would be both significant for monitoring purposes and easy to reach. In particular, six AE sensors were applied to the north-east angle of the tower at an average height of ca 9.00 m above ground level, immediately above the terrace atop the arcade. In this area, the double-wall masonry has an average thickness of ca 2.45 m (see Figs. 2 and 3). AE monitoring began on 23 September 2010 at 5:40 PM, and ended on 28 January 2011 at 1:00 PM. It was carried on for ca 2915 hours, corresponding to 122 consecutive days. The arrangement of the AE sensors, shown in the photos in Fig. 4, corresponds to the scheme illustrated in Fig. 5. The sensors were glued to the outer surface of the masonry with cold set silicone based adhesives, selected on account of their good ultrasound

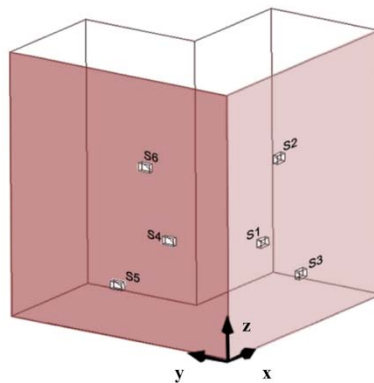
Figure 5. Axonometric scheme of the points of application of the AE sensors at the north-east corner of the tower.

The coordinates of the sensor application points are given in Table 1. The origin of the coordinate system of reference, as can be seen in Fig. 5, is at the bottom corner of the masonry at the intersection with the outer surface of the terrace surrounding the tower.

Sensors	x	y	z
S1	51.50	0.00	98.00
S2	78.00	0.00	171.0
S3	110.00	0.00	53.00
S4	0.00	63.50	102.00
S5	0.00	121.06	50.00
S6	0.00	89.00	167.00

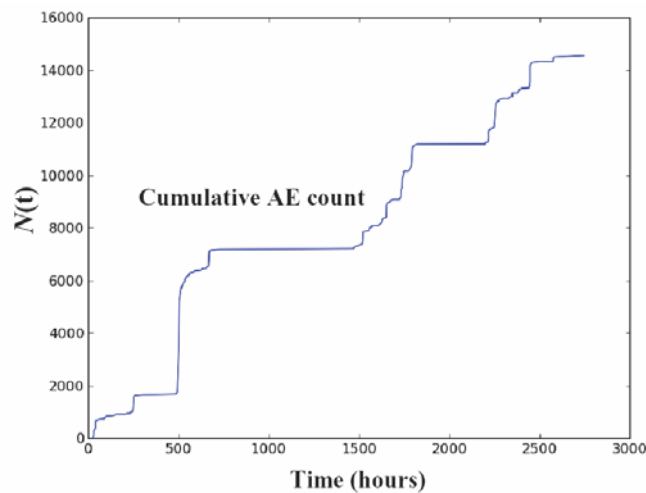
Figure 6. Cumulative AE count based on the data collected at the northeast corner of the tower, from 5:40 PM of 23 September 2010, to 1:00 PM of 28 January 2011.

Figure 6 shows a plot of the cumulative AE count obtained on the basis of the number of events detected per monitoring day. The curve was plotted starting from the date of application of the sensors to the time the sensors were permanently removed. Throughout the monitoring period, the threshold level for the detection of the input signals coming from the PZT transducers was kept at 100 mV. Based on the authors' experience, in fact, this level is the most significant for the detection of AE signals from damage processes in non-metallic materials such as concrete and masonry [1,2,5,9].

From the curve in Fig. 6 it can be seen that the masonry is actually undergoing a damage process. The plot of the cumulative AE count, in fact, is characterised by jumps reflecting sudden increases in N that are seen to occur at certain time intervals. The discontinuities in the cumulative AE count curve denote the critical moments during which the release of energy from the microcrack formation process is greatest.

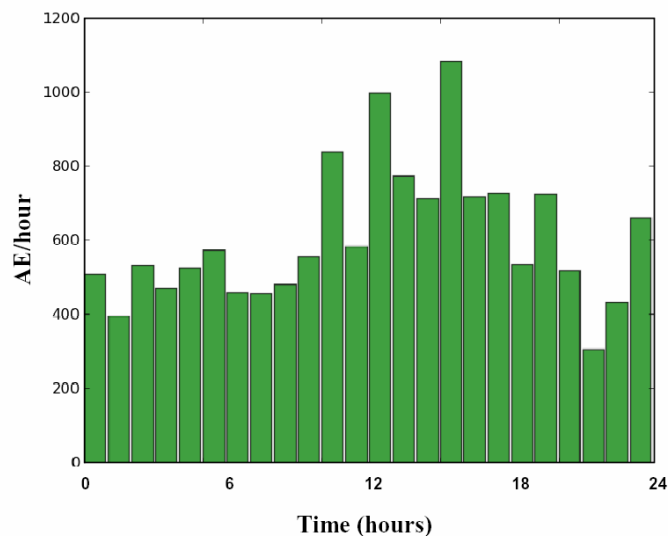
Figure 7. AE count hourly distribution chart over a 24 hour time span, as determined for the entire monitoring period.

The AE count hourly distribution chart over a 24 hour time span, as determined for the entire monitoring period, is shown in Fig. 7.

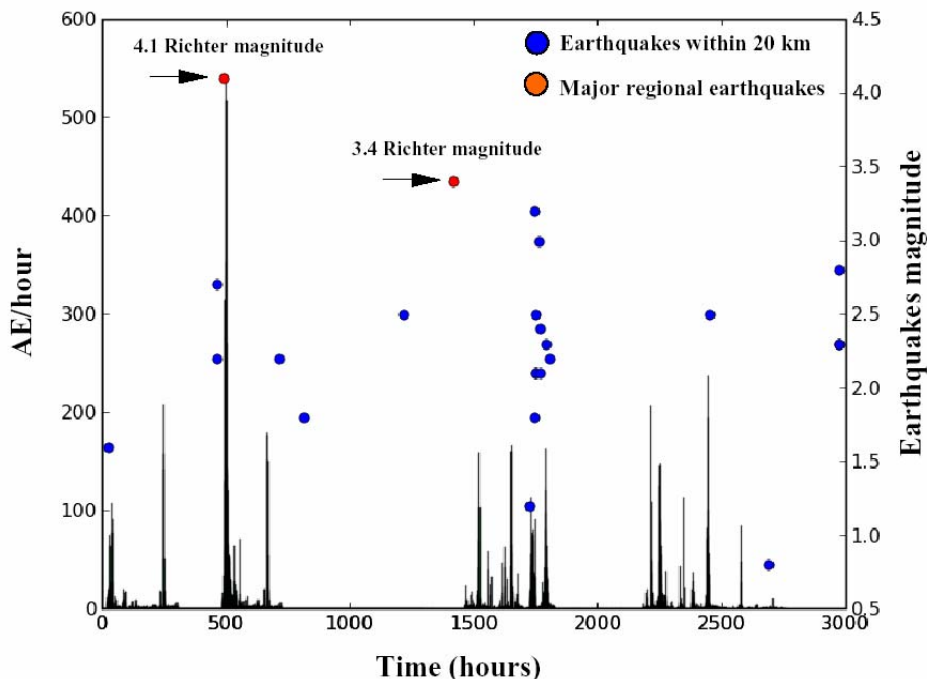
Figure 8. Historic series of the AE differential count and the earthquakes detected within a 20-km radius from the Bologna city centre. The chart also shows the two strongest regional earthquakes, which occurred in Rimini area and in the Modena Apennines. This chart refers to the entire monitoring period.

The chart in Fig. 8 shows the AE count rate per hour, the earthquakes recorded within a 20-km radius from the city centre, and the two strongest quakes that hit the region. All the quakes, the two most important ones (denoted with red dots) and the weaker ones (blue dots), are shown as a function of time of occurrence and magnitude.

Fig. 8 reveals a *correlation between the AE events recorded experimentally and the seismic events*. As can be seen, in fact, the energy peaks measured through the AE count rate almost invariably occurred during a seismic event. In particular, the highest AE count peak (ca 500) was detected on 13 October, at 11:43 PM, when the Rimini area was hit by the 4.1 magnitude quake. Hence, this seismic event is the pulse phenomenon that resulted in the highest damage effect on the tower.

The second strongest earthquake, i.e., the 3.4 magnitude quake that hit the Modena Apennines on 21 November at 4:10 PM, does not introduce any significant change to the chart shown in Fig. 8, since the AE activity detected during this event was rather limited.

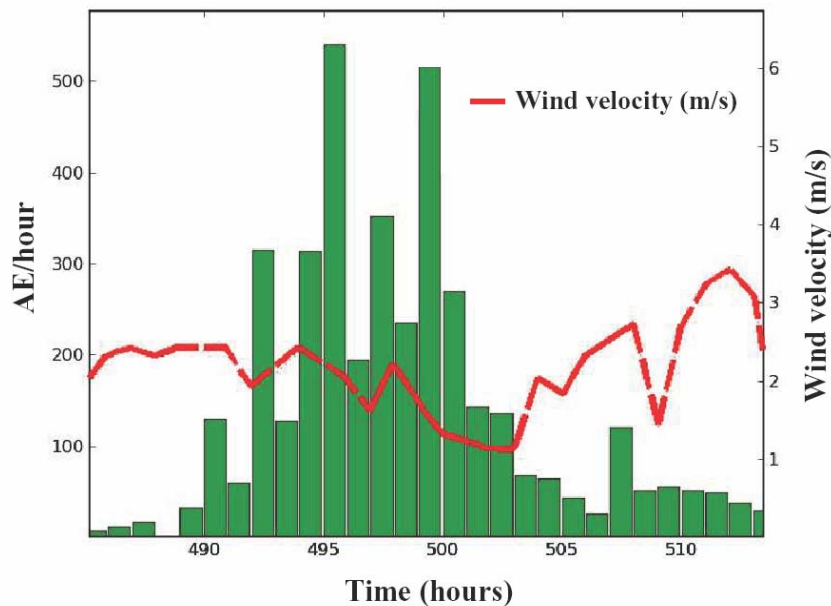
Figure 9: AE rate and wind velocity measurements during the monitoring period in a time window of 30 hours just after the earthquake of 13 October 2010.

velocity sensors applied at the height of 78 m on the monitored tower, and averaged for each hour. The wind velocity intensities measured during the monitoring period were comprised between 1 and 7 m/s. These velocities were unable to generate sensible aerodynamic loads on the structure. In the chart of Fig. 9 are represented in detail the AE count rate and the wind velocity in a time window of 30 hours just after the earthquake that hit the Rimini area on 13 October 2010. The graph shows that the peaks in the AE count rate do not correspond with those of the wind velocity. Moreover, the chart of Fig 10 relates the wind velocities and the AE count rate obtained during all the monitoring period (2915 hours). This graph makes more clear that the two phenomena are completely statistically unrelated.

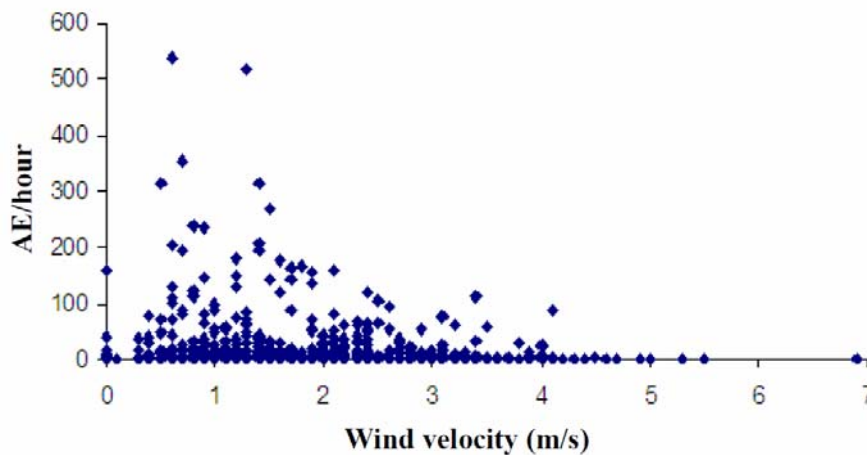
Figure 10: Chart relating the wind velocity and the AE count rate during all the monitoring time, the two time series seem to be statistically unrelated.

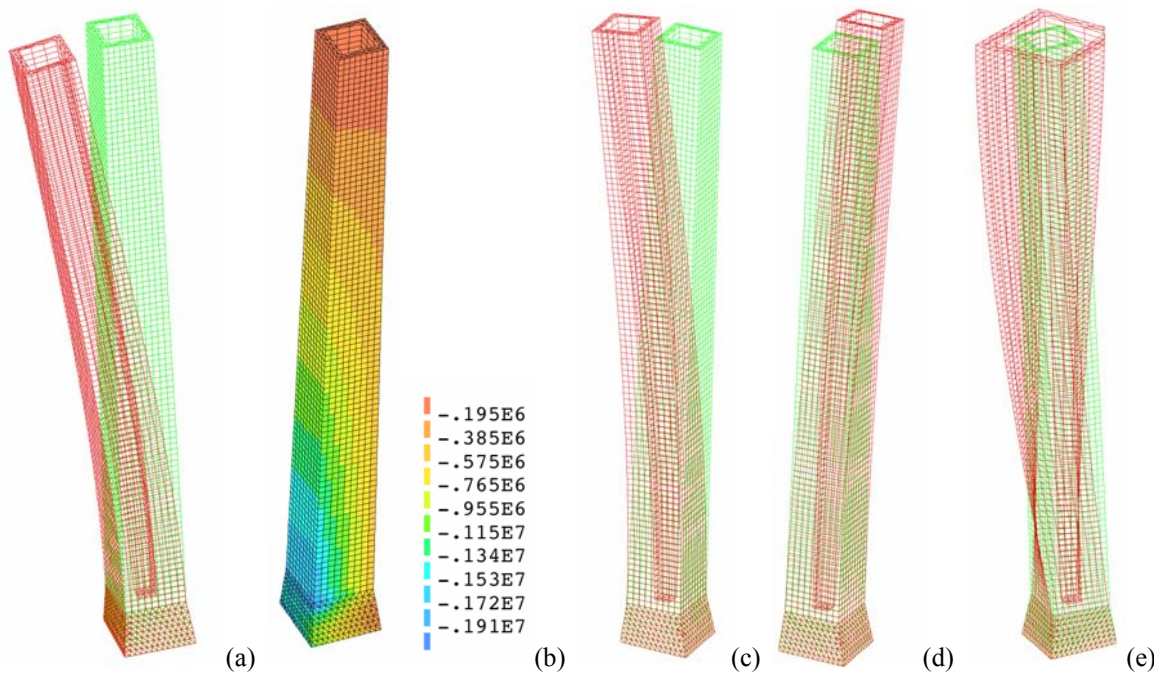
Figure 11. Deformation due to the effect of gravity (a); vertical stress expressed in MPa (b); first modal shape (c); second modal shape (d); fifth modal shape (e).

The preliminary linear elastic analysis considered only the self-weight of the tower (Fig. 11a). It was possible to assess that the elastic deformation of the tower is about 8 cm, which is about 1/30 of the present total deviation from verticality.

The level of stress in the masonry of the tower (Fig. 11b) is generally low, although in proximity of the monitored area, the level of vertical stress approach 2.1 Mpa, which can be critical in case of very poor masonry.

The preliminary modal analysis showed that the first mode is bending in the west-east plane, with a resonance frequency of 0.357 Hz (Fig. 11c). The second mode is bending in the orthogonal plane, with an eigen-frequency equal to 0.365 Hz (Fig 11d). The third eigen-frequency is 1.75 Hz, and the fourth is 1.78 Hz. The fifth mode is torsional (Fig. 11e) with an eigen-frequency of 3,07 Hz. Those results agree quite well with more detailed dynamic analyses carried out by other Authors [11].

The maximum vertical stress in the tower is compatible with the acquire rate of acoustic emissions from the monitored region. The fact that the first modal shape tends to increase the stress in the same area agrees well with the increase of acoustic emissions connected with seismic events.
